Analysis of the explosion of a liquefied-natural-gas road-tanker

This article describes a liquefied-natural-gas tanker accident in the Spanish province of Murcia, with subsequent ignition and explosion of the cargo. The effects were notable in terms of thermal radiation, overpressure blast wave and flying shrapnel. This was the second known accident of this type in the world. In 2002 a similar accident occurred in Tivissa (Tarragona). This article looks at the possible causes, draws conclusions and puts forward recommendations for avoiding accidents of this type in the future.

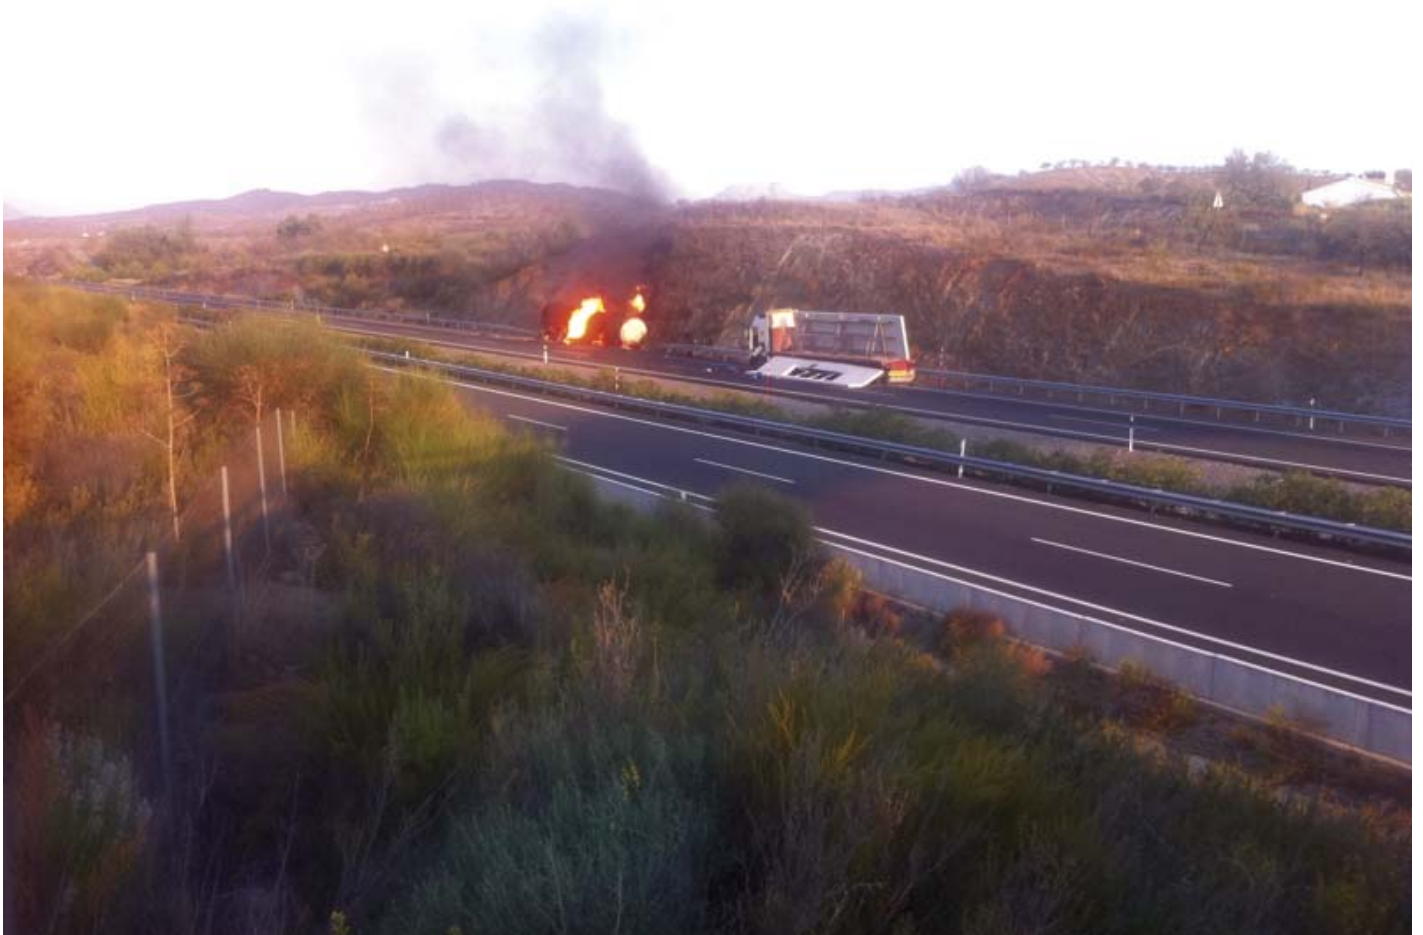
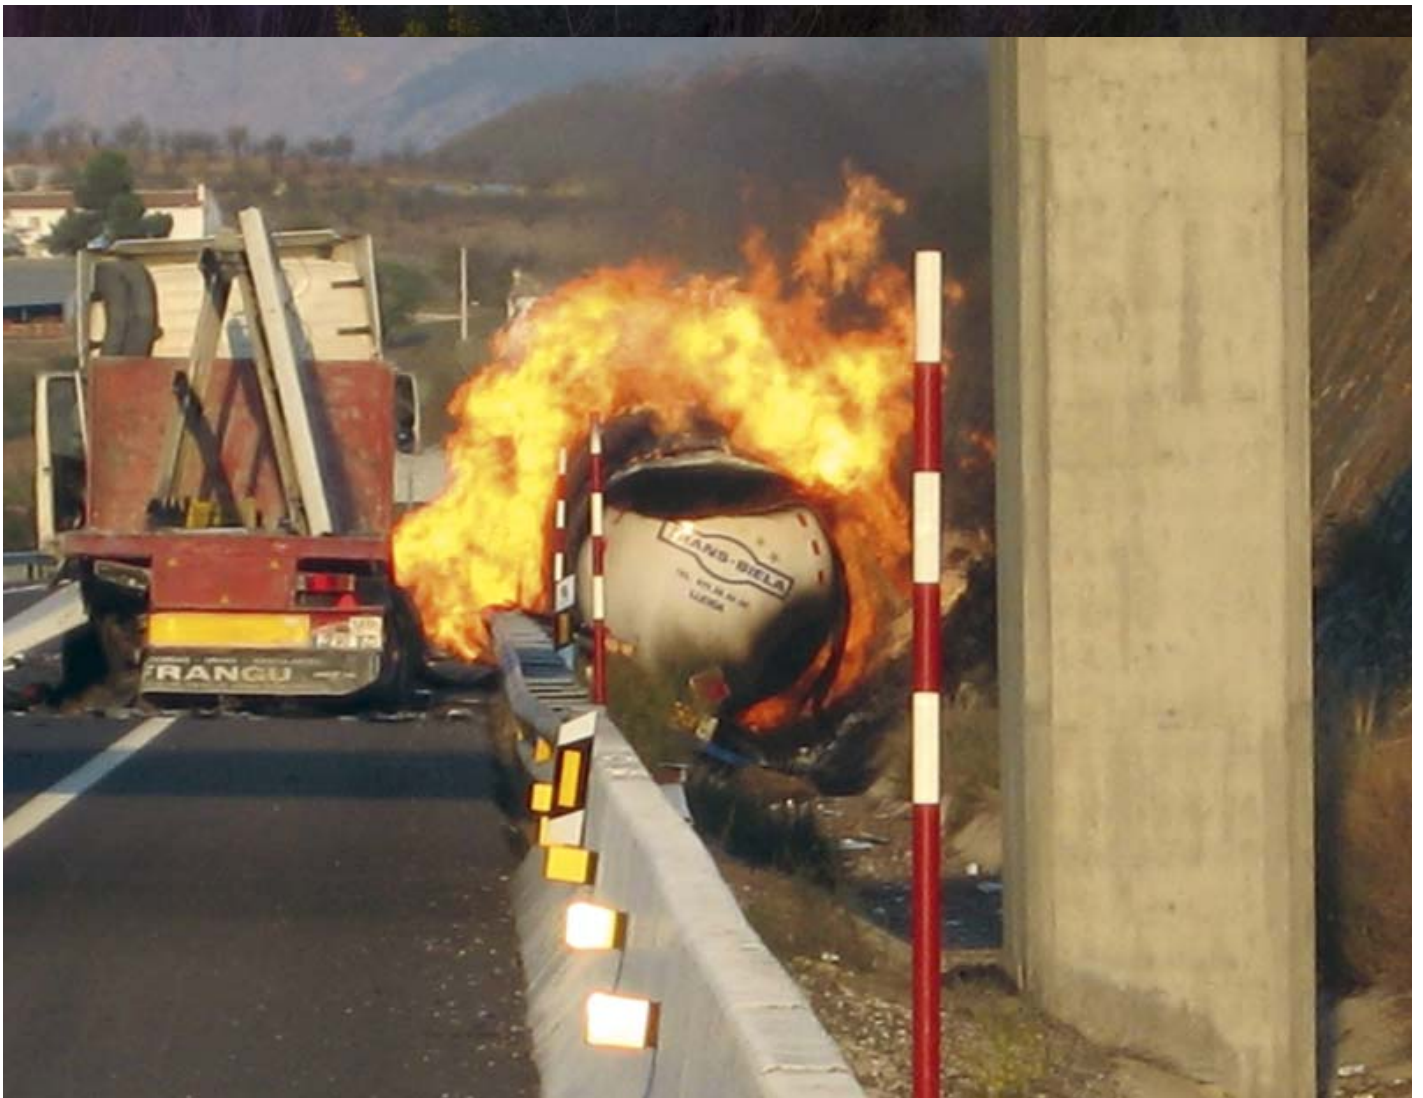
About 8:00 hours that morning a lorry carrying large prefabricated concrete sheets stopped on the motorway hard shoulder due to a breakdown. About twenty minutes later the road tanker ran into the back of the parked lorry. As a result of the crash the driver lost control of the road tanker, which ran on past the flat-bed lorry, broke through the hard-shoulder crash barrier and became wedged in a ditch against the embankment. The lorry ended up on its wheels, leaning over to the right due to the slope of the ditch; the cab was jack-knifed back towards the trailer, remaining trapped between trailer and embankment.

Figura 2. Situation of the vehicles after the accident. Source⁽²⁾.

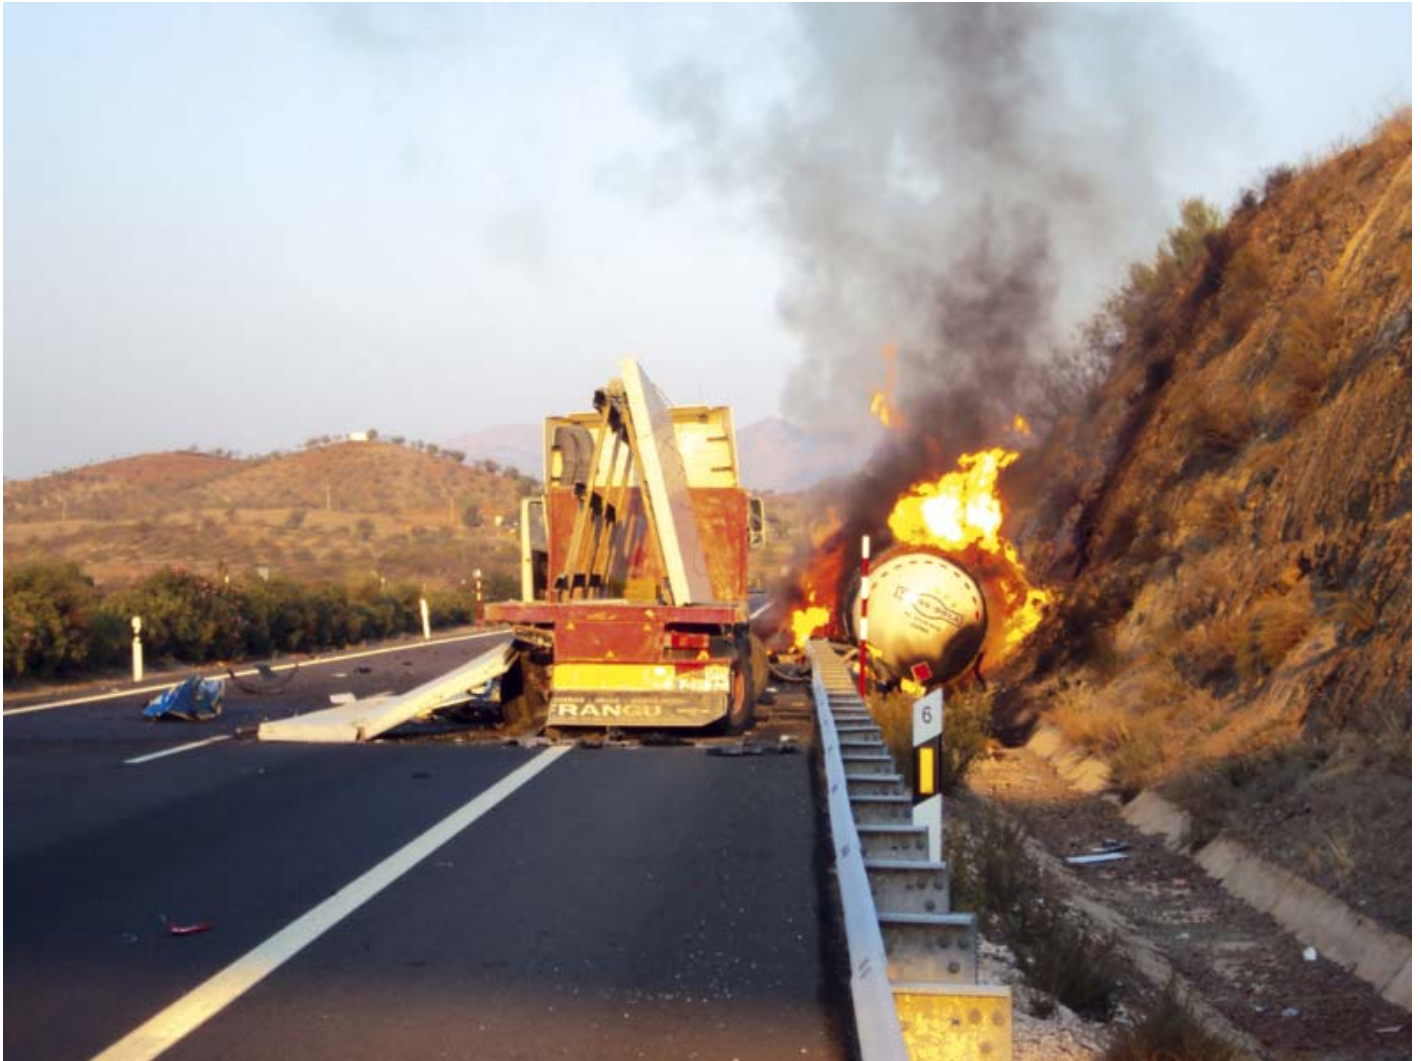
that the crash caused a leak in the tanker's load; subsequent friction or the vehicle's engine or a similar cause would then act as ignition source. This chimes in with the reports of several eye witnesses, declaring that they heard "a sort of loud hiss", as well as the diverse tanker fragments found around the flat-bed lorry and the ignited plumes. Several possibilities have been put forward as the cause of the leak. As well as the cab the central part of the tanker also crashed into the parked flat-bed lorry. This central part houses the loading and unloading devices, safety valves and level gauges. A large part of the blue cabinet containing the abovementioned devices was found very close to the flat-bed lorry. This would seem to show that the valve-containing part suffered a collision, with resulting damage to some of the pipelines.

Figure 6. Remains of the tanker's lower central cabinet (blue fragments to the left). Source: On-the-spot witness.

The remains of the cab show huge deformations on the righthand side, indicating the scale of the impact. It looks as though the cab jack-knifed round completely and dragged along the whole flat bed and cab of the parked vehicle, the cab itself then rebounding in turn against the cabinet, either directly or indirectly. This could be the reason for the breakage of the fastening elements of the concrete sheets, anchored to the side of the flat bed. Another possibility is that some of the pipelines were cut by the crash-barrier posts when the tanker lurched into the ditch.

What seems to be totally ruled out, even though this working hypothesis was considered at first, is perforation of the tanker from the crash against the back corner of the flat bed. If so there would be remains of the shell and insulation on the back part of the broken-down lorry and no such evidence has come to light. Moreover, all the photos studied show clearly that the leak was located in the lower central part. In any case these hypotheses are not mutually exclusive; the combined effect of several of these causes might have broken some of the pipelines not fitted with inner gas-tight valves, producing a leak of the cargo.

4. Last but by no means least, urge the competent authorities to dictate that liquefied natural gas should always be transported in double-walled road tankers, for greater safety, or, in the case of single-walled tankers, ensure that there are no pipelines directly communicating the liquid and gaseous phases with the exterior, lacking any additional cut-off device in the event of accidental sectioning.

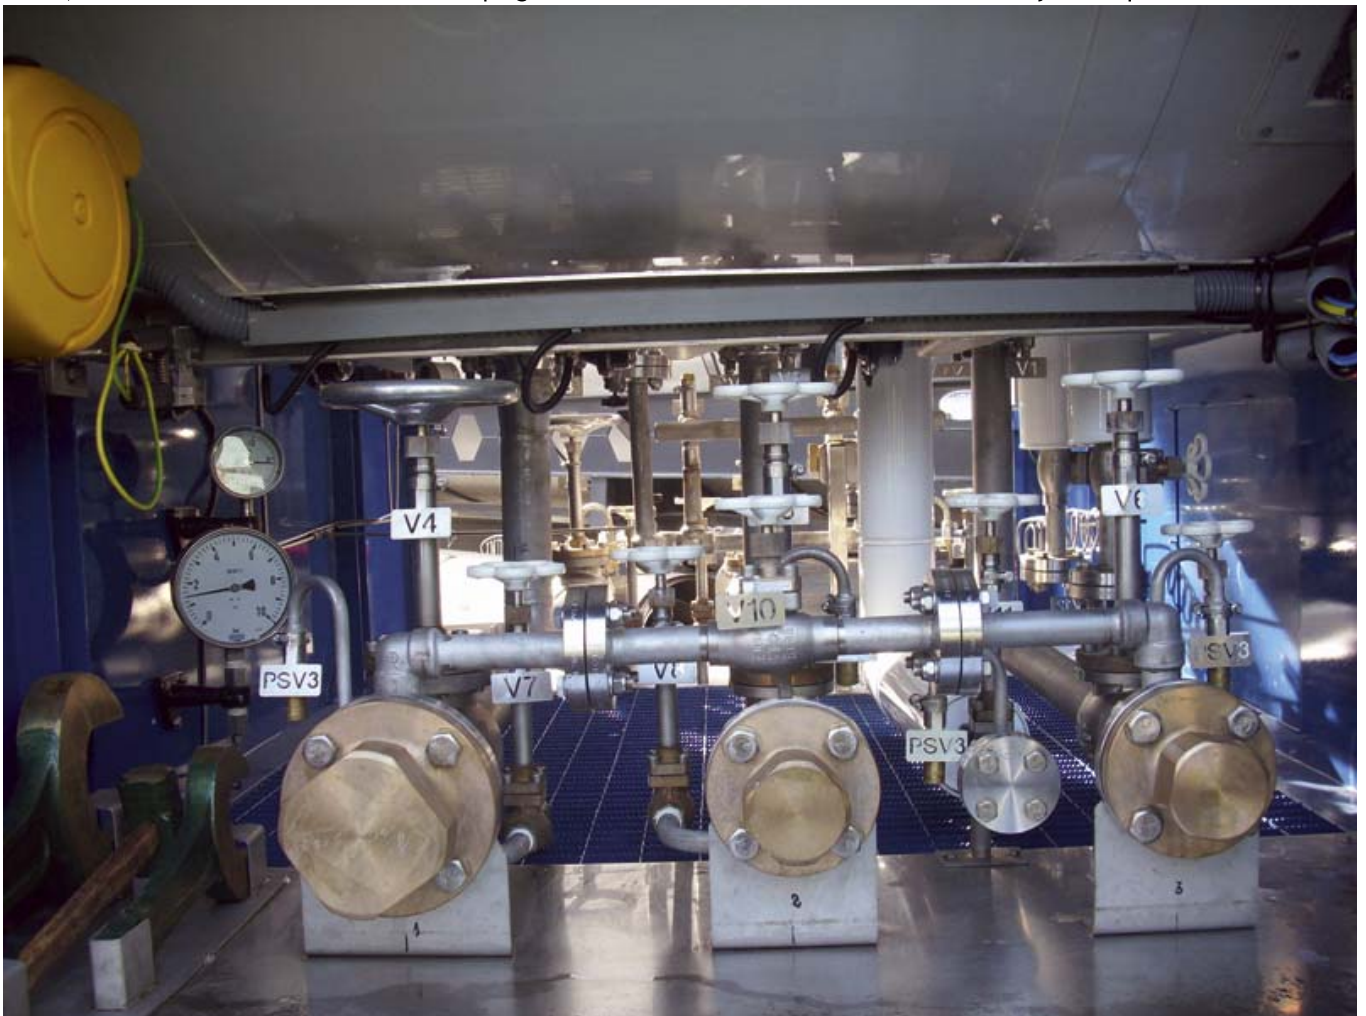
Figure 7. General view of the set of valves and pipelines. In the foreground, the loading and unloading connections. The right-hand photo shows a detail of the inner plug valves. Source⁽⁴⁾: Authors.

Of all the abovementioned devices and pipelines only the loading and unloading connections are fitted with inner seal valves guaranteeing tank gas-tightness; in the event of any breakage in pipes connected up to these valves, any leaks would be blocked off from inside. Although it seems obvious that the tanker's cabinet area struck the parked flat-bed lorry, as shown by the remains of this cabinet on the road surface, the available photos do not allow us to ascertain the state of these valves since this part of the inside of the tanker is not shown. Nonetheless, this hypothesis seems less probable than breakage of another pipeline not fitted with plug valves.

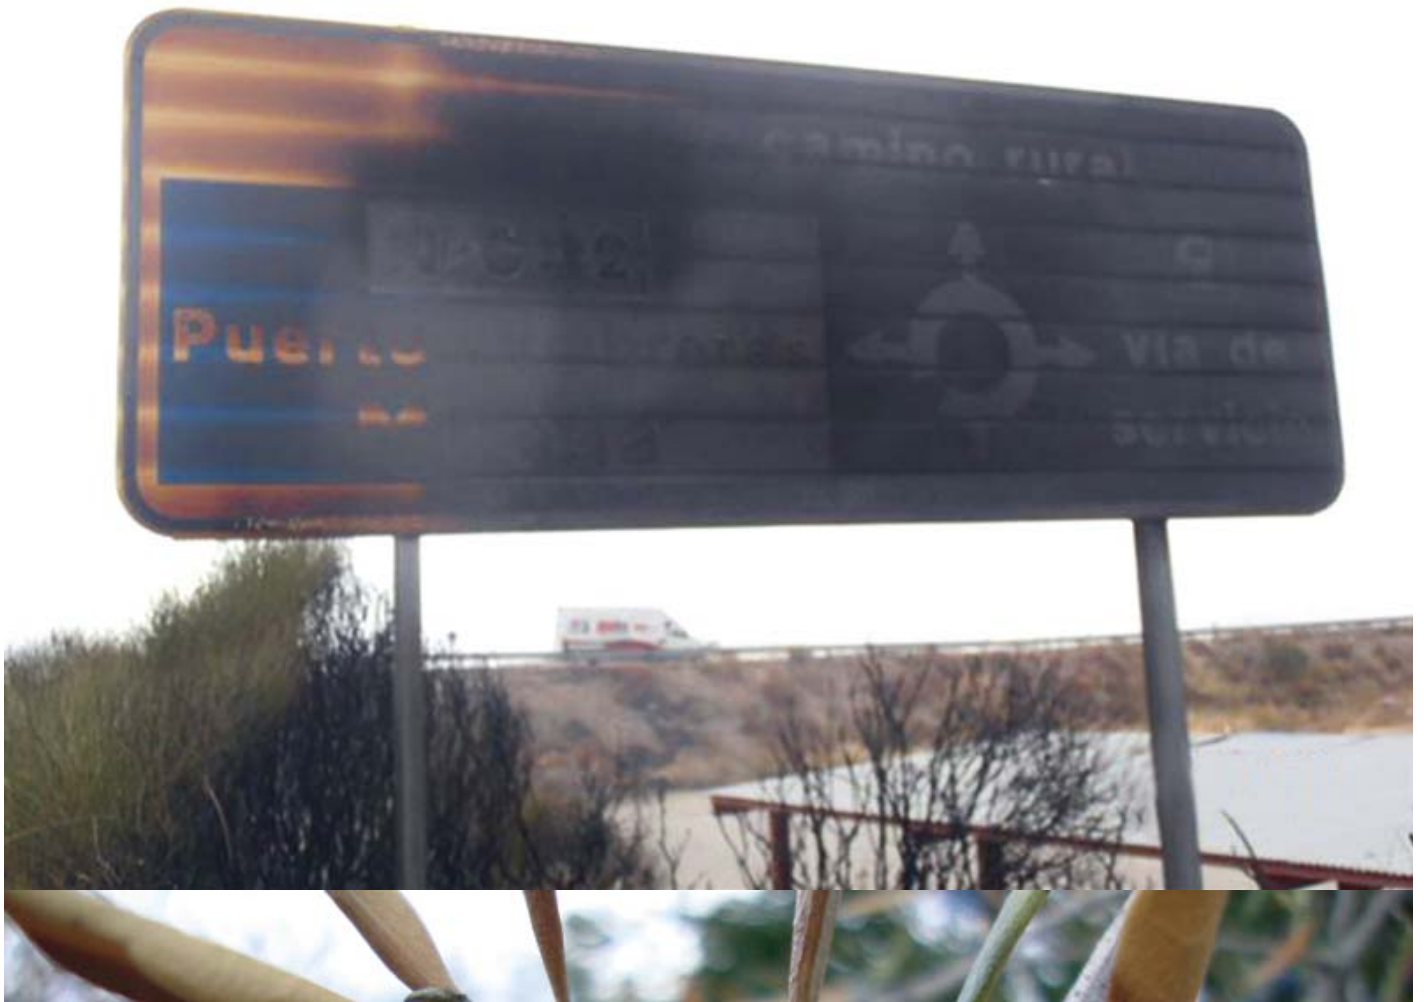
According to J.E.E., fire broke out all around after the explosion. This is confirmed by the burn marks in the terrain revealing the spread of small scrub fires, especially on the hard shoulders of the service road and the central reservation of the motorway. Olive trees and their fruit, growing at 110 metres from the explosion point were affected, as shown in the following photograph.

Figure 10. Radiation damage to a road sign and olive tree. Source⁽⁴⁾: Authors.

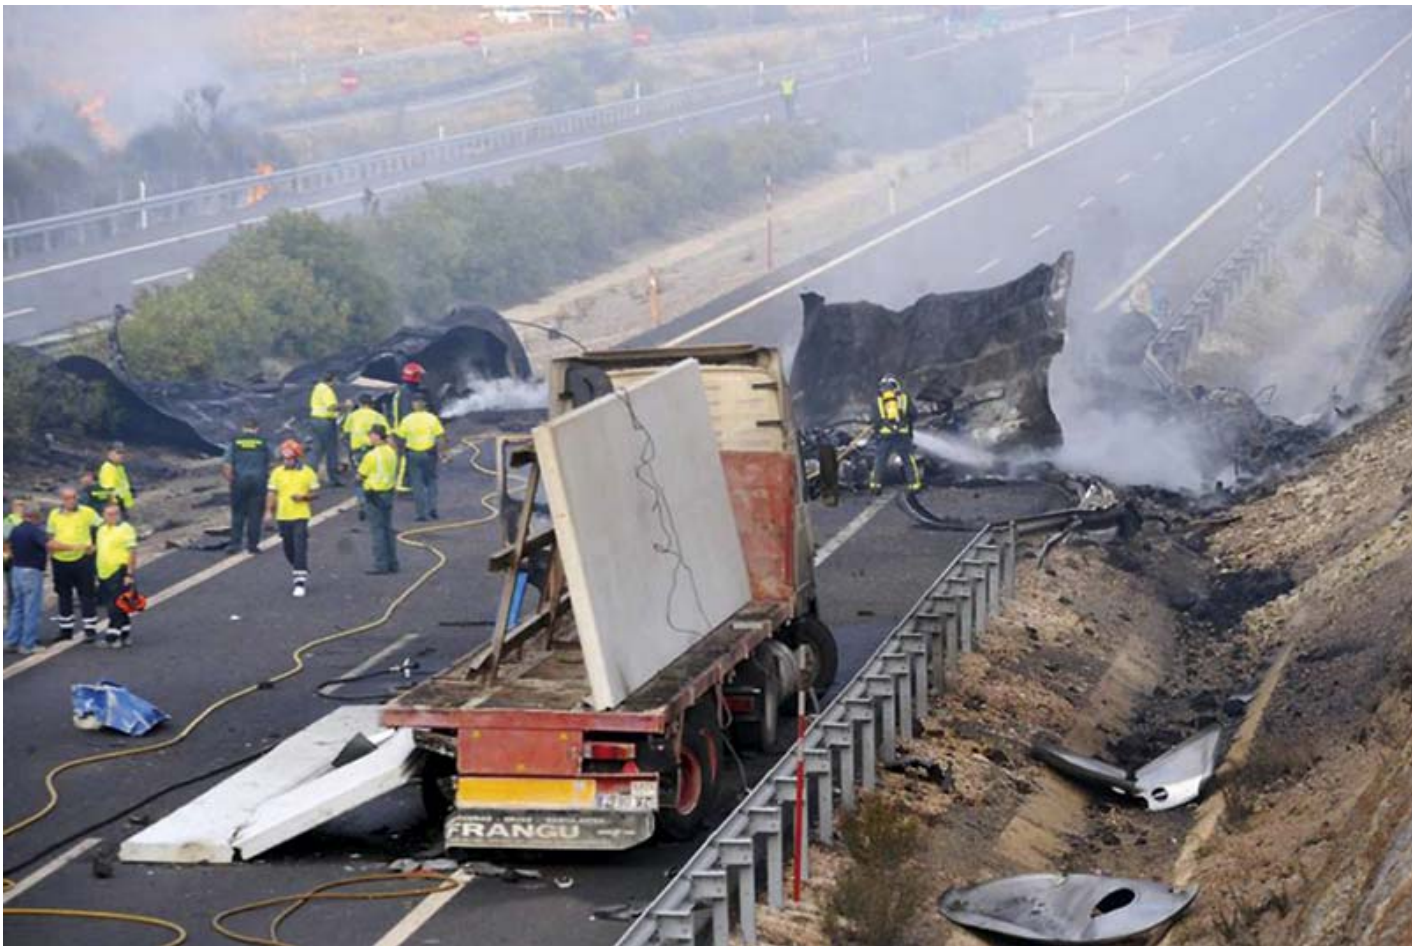
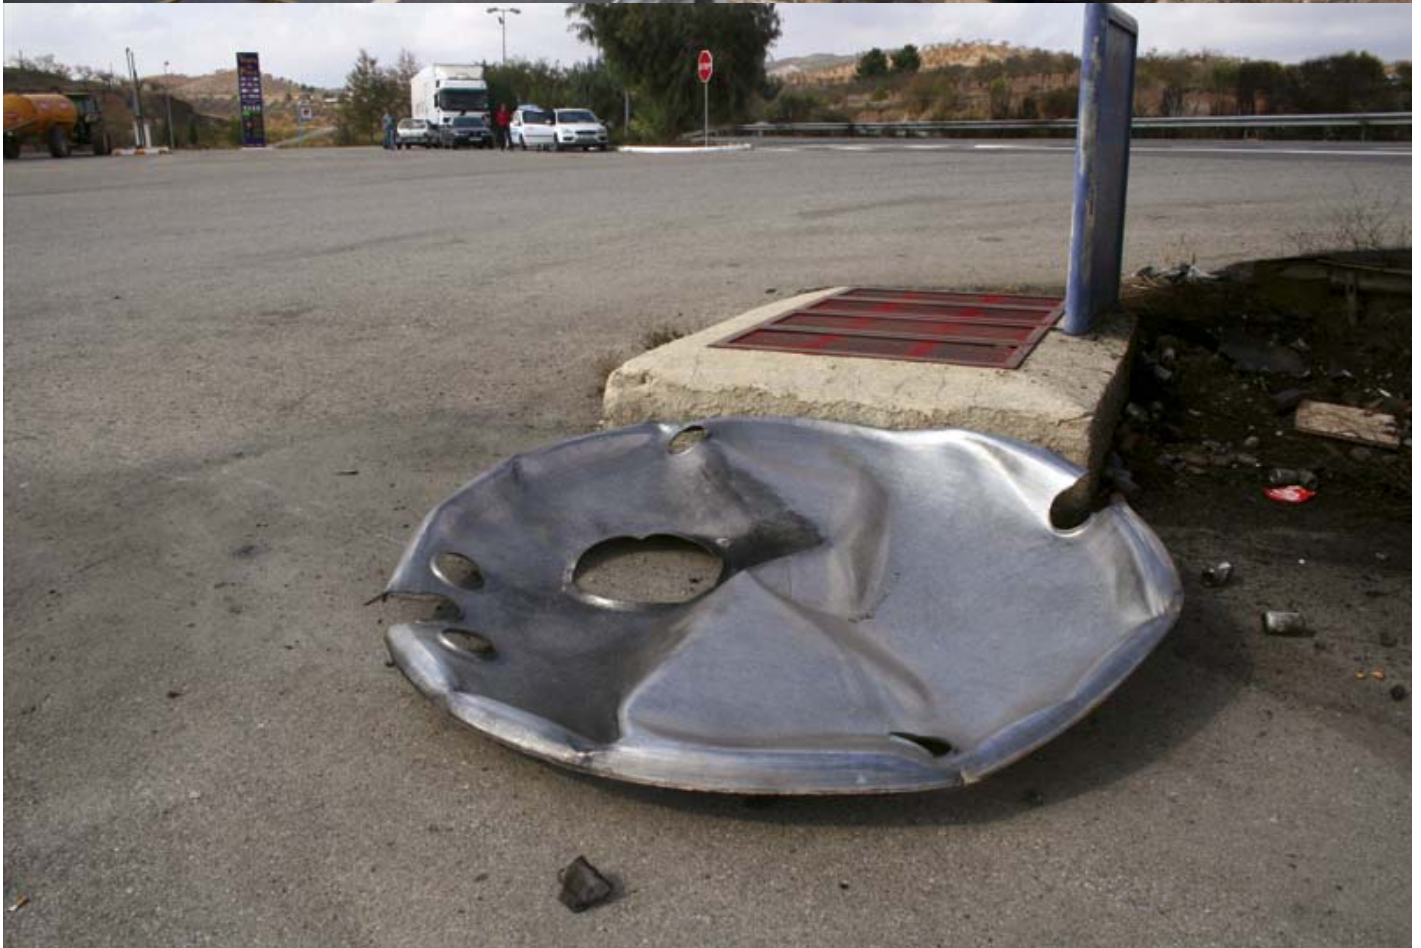
Two of the baffle plates remained beside the tanker, as shown in the following photograph. Another crossed the roadway and struck the ditch on the other side.

Figure 13. In the foreground, two of the baffle plates of the road tanker. Source: On-the-spot witness.
