# Accident investigation following the Vest Tank explosion at Sløvåg

Revision 03 – English Version

Police District Hordaland, Kripos, and DSB

T. Skjold, K. van Wingerden, R. Abiven, and Ø. Larsen

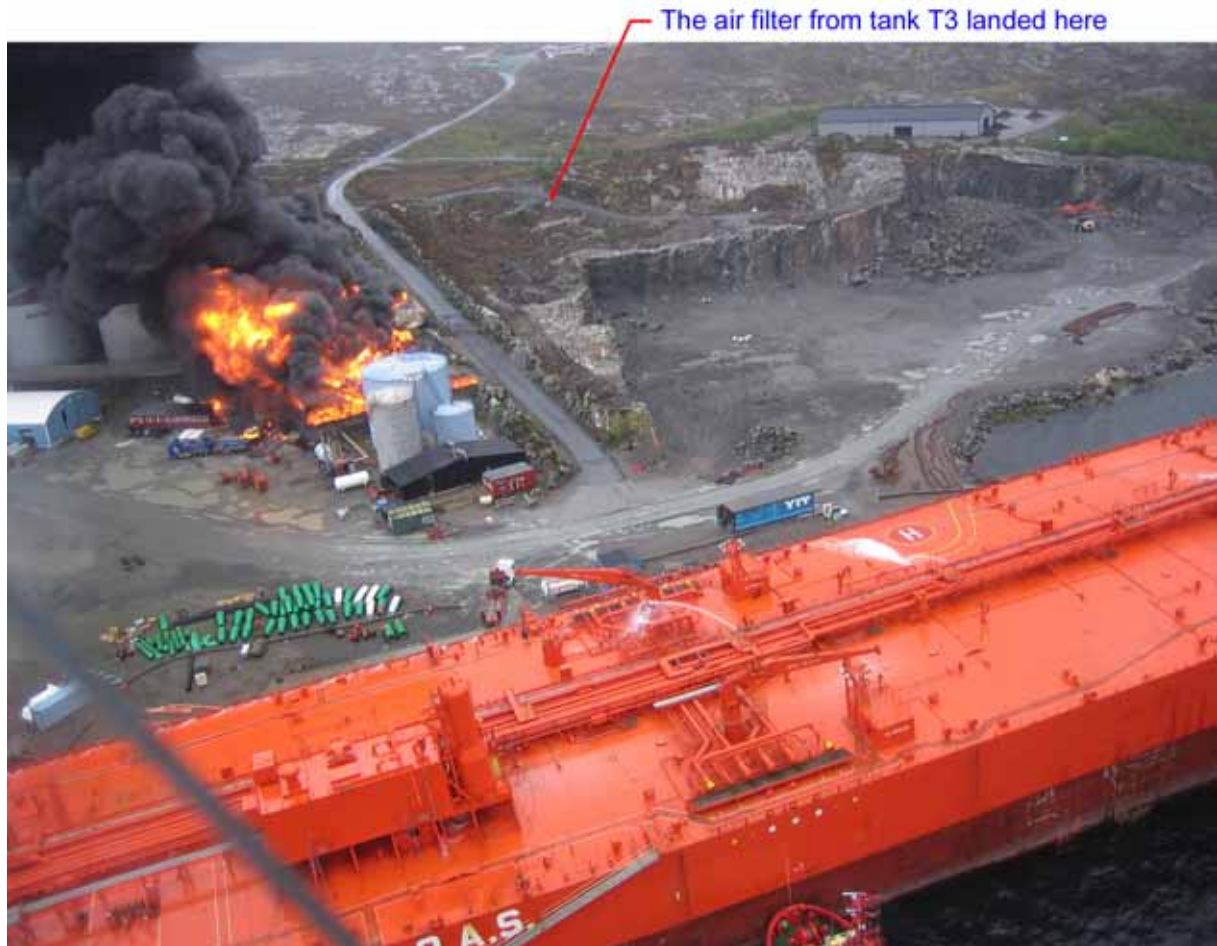
An extensive pool fire developed in Tank Farm II shortly after the first explosion. Figure 1-4 shows the fire in Tank Farm II about 45 minutes after the first explosion, when the fire had just reached the red office building. Figure 1-5 shows a series of pictures taken by the crew onboard M/T Karen Knutsen that clearly documents the escalation of the fire scenario. Figure 1-6 illustrates the extensive damage to Tank Farm II, the office building, and some tank trucks outside the tank farm.

**Figure 1-4** Picture taken from a helicopter from Norsk Luftambulans (Norwegian Air Ambulance) about 45 minutes after the first explosion, showing the tanker M/T Karen Knutsen, most of the tank facility, and the extensive fire in Tank Farm II. The fire in the red office building has started, presumably due to radiative heat transfer from the fire in the tank farm. The picture also shows where the air filter from tank T3 landed, as well as various details not included in Figure 1-2. Photograph provided by Lasse Fossedal from Norsk Luftambulans.

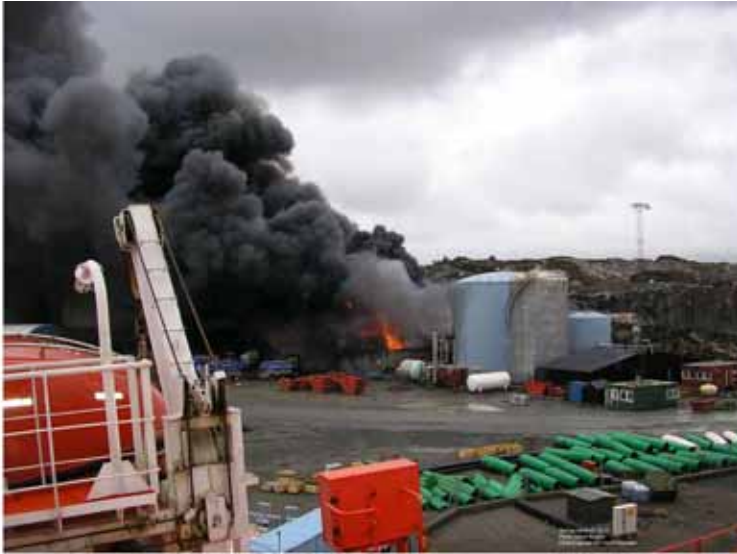
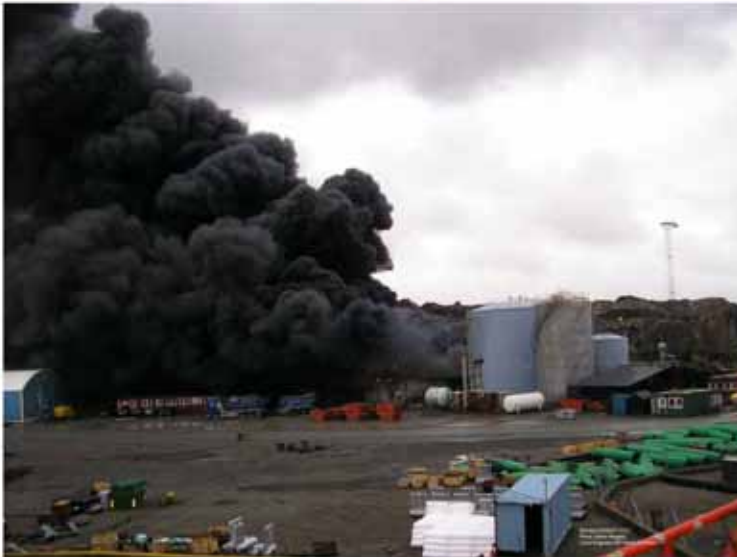
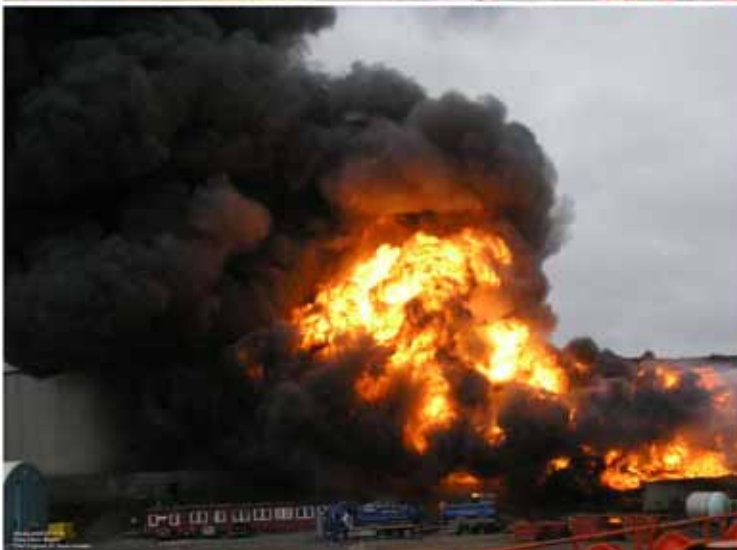
**Figure 1-5** A series of pictures taken from M/T Karen Knutsen that illustrates how the fire in Tank Farm II developed during the first minutes after the first explosion in tank T3 on 24<sup>th</sup> May 2007. Photographs provided by Glenn Rogers, Chief Engineer, M/T Karen Knutsen.

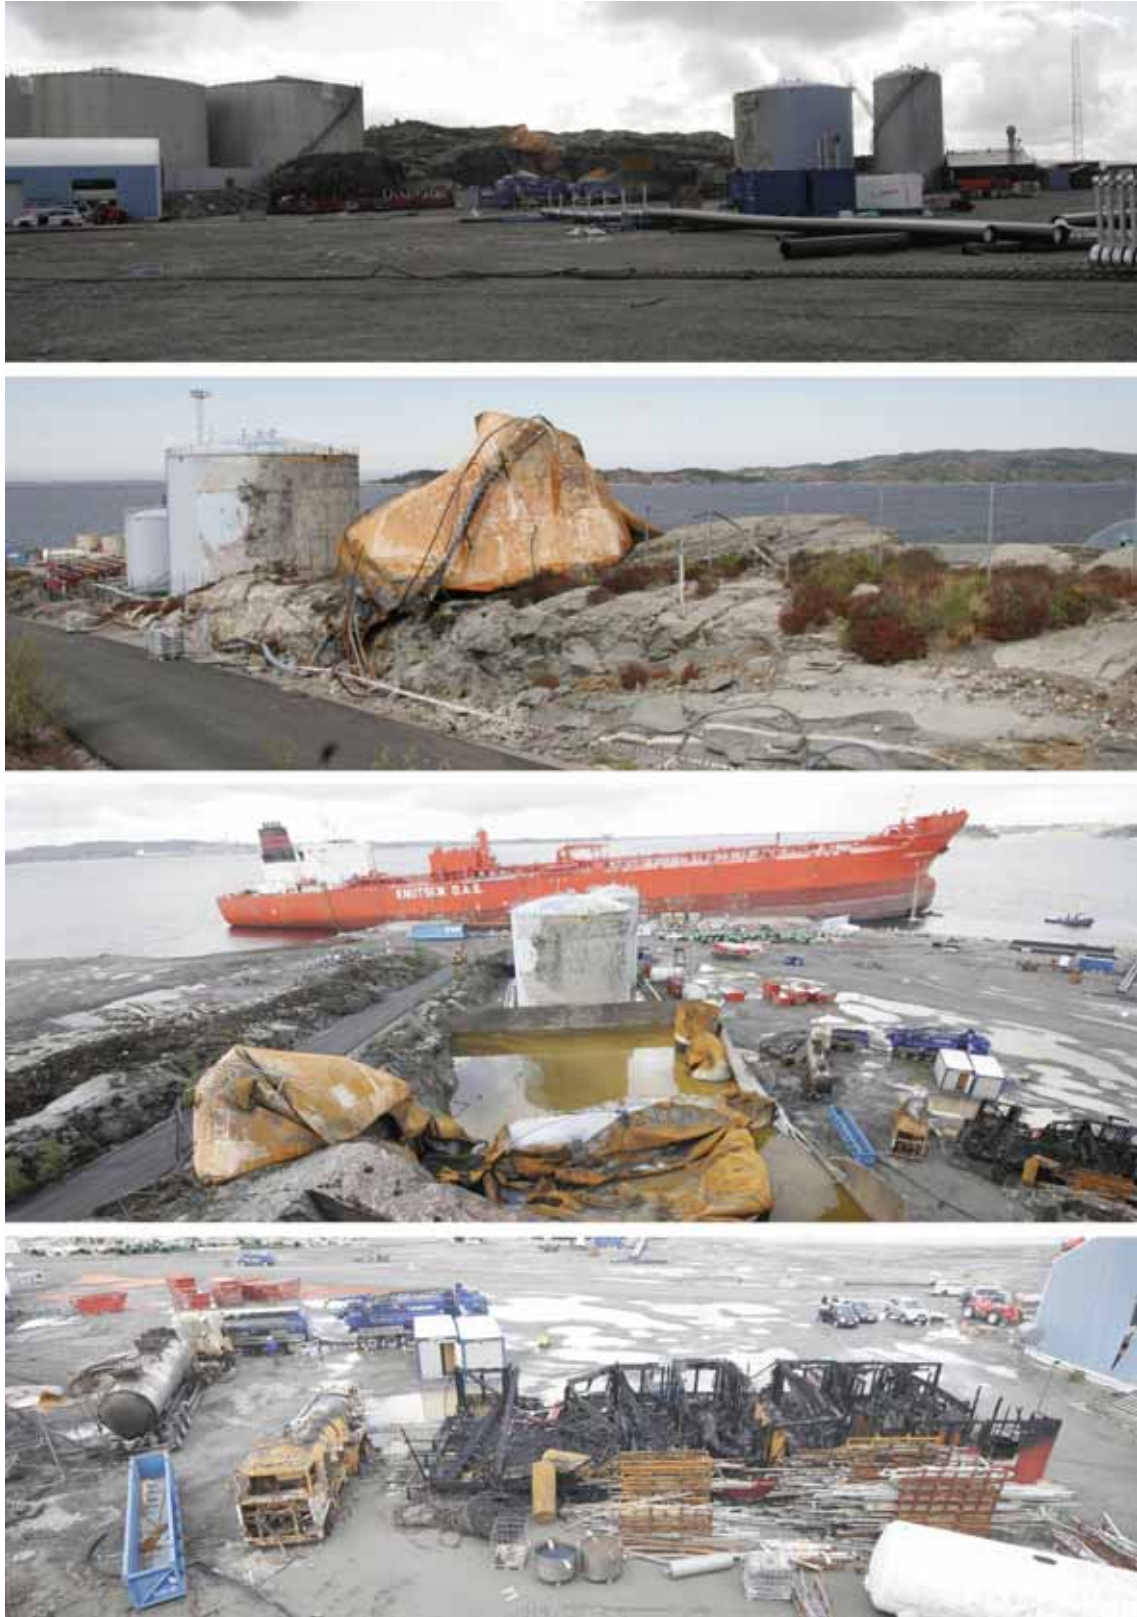
**Figure 1-6** Overview pictures illustrating the tank facility at Sløvåg after the accident on 24<sup>th</sup> Mai 2007: Tank farm II viewed from the quay (25<sup>th</sup> May 2007); the remains of tank T3 viewed from the road (26<sup>th</sup> May 2007); Tank farm II with Tank farm I and M/T Karen Knutsen in the background (25<sup>th</sup> May 2007); damages to the trucks and the red office building (25<sup>th</sup> May 2007); photographs from the Norwegian Police.

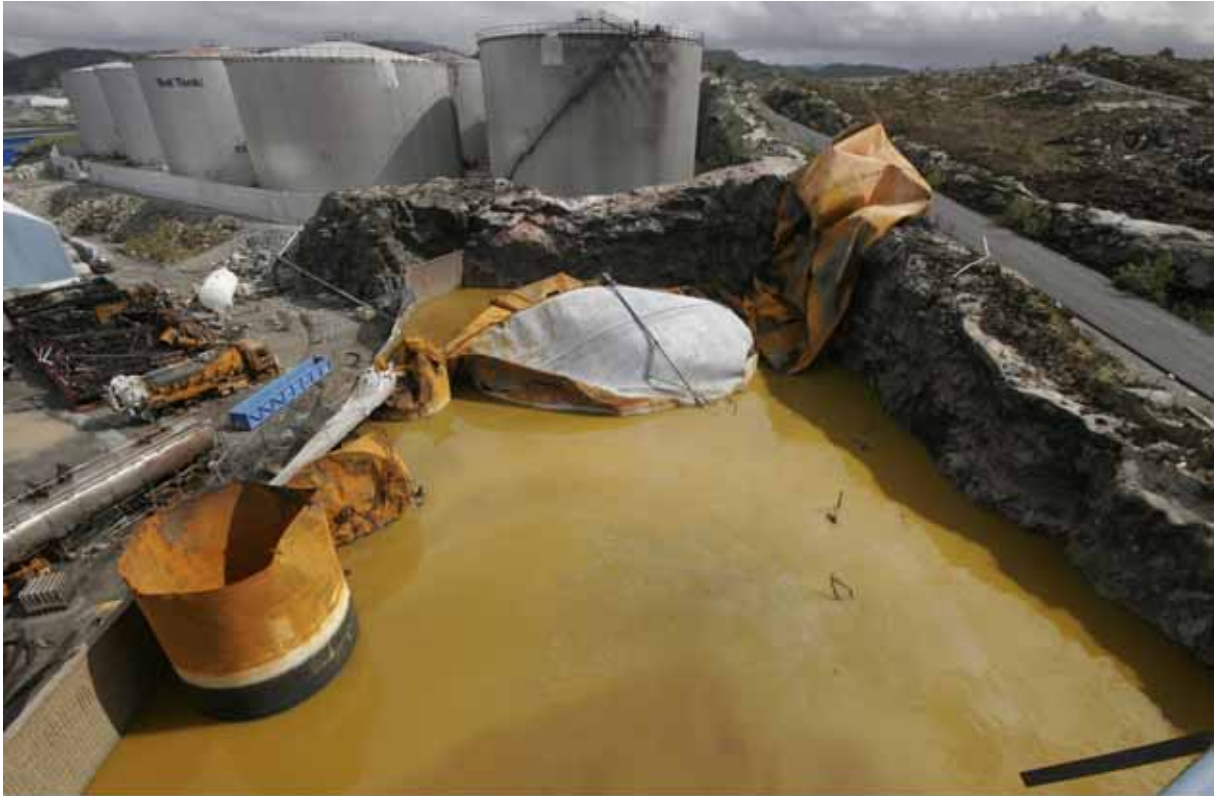
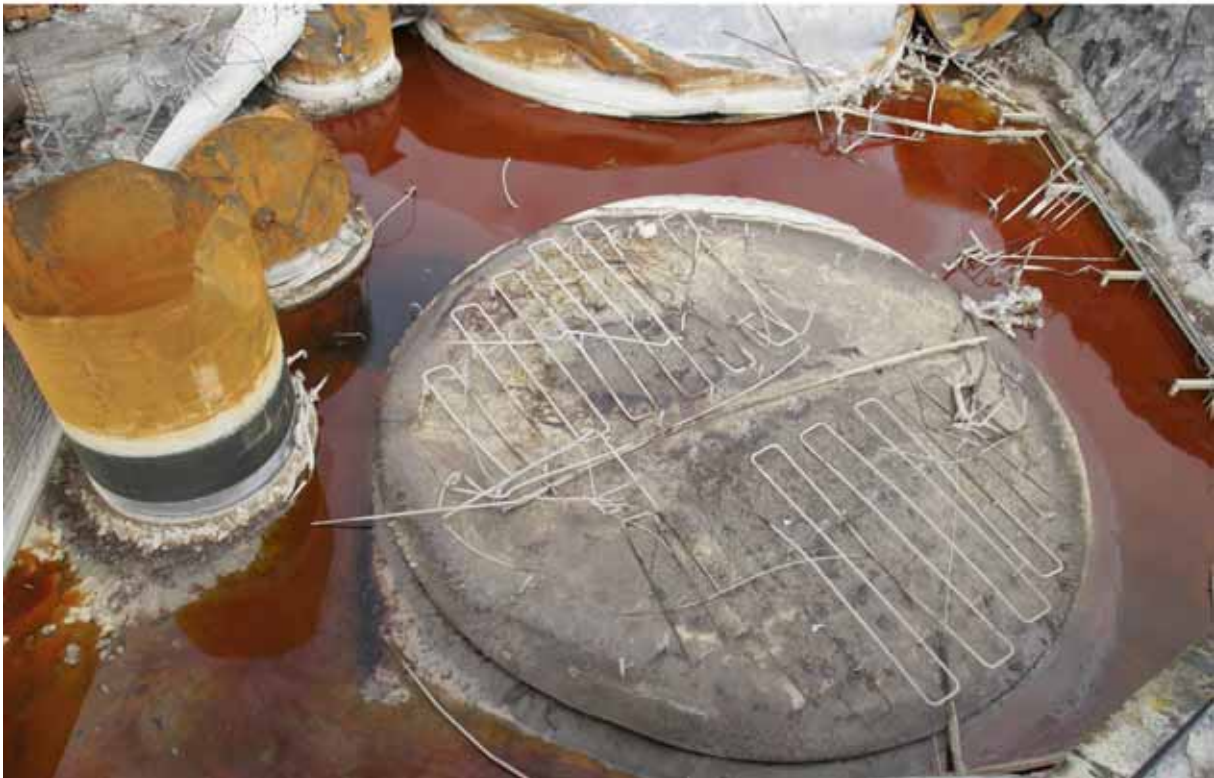
Figure 3-2 and Figure 3-3 illustrate the damage to Tank farm II after the accident on 24<sup>th</sup> May 2007:

- Tank T3 exploded first: the base/wall weld ruptured, and the upper part of the tank was launched up in the air and landed in the north-eastern corner of Tank farm II, leaving the base of the tank on the ground; the roof of the tank landed even further away.
- Tank T4 exploded shortly after; it is likely that projectiles from tank T3 hit it.
- The roof on tank C1 blew off during the subsequent fire, and tanks C2 and C3 collapsed.
- Parts of the bund wall collapsed.
- Two of the three tank lorries outside the bund wall were more or less completely burnt-out: the lorry delivering the hydrochloric acid and an old vacuum truck placed near the office building; in addition, there was some damage to the blue tank lorry collecting waste liquid from tank C1.

**Figure 3-2** Tank farm II viewed from the south (pictures taken from the roof of tank T2, see Figure 1-2). The upper picture shows the three smaller tanks C1-C3 along the bund, the upper part of T3 thrown partly out of the tank farm, and T4 collapsed; the base of T3 is below the water (The Norwegian Police, 25<sup>th</sup> May 2007). The lower picture shows the base of tank T3 with the heating system (The Norwegian Police, 31<sup>st</sup> May 2007).

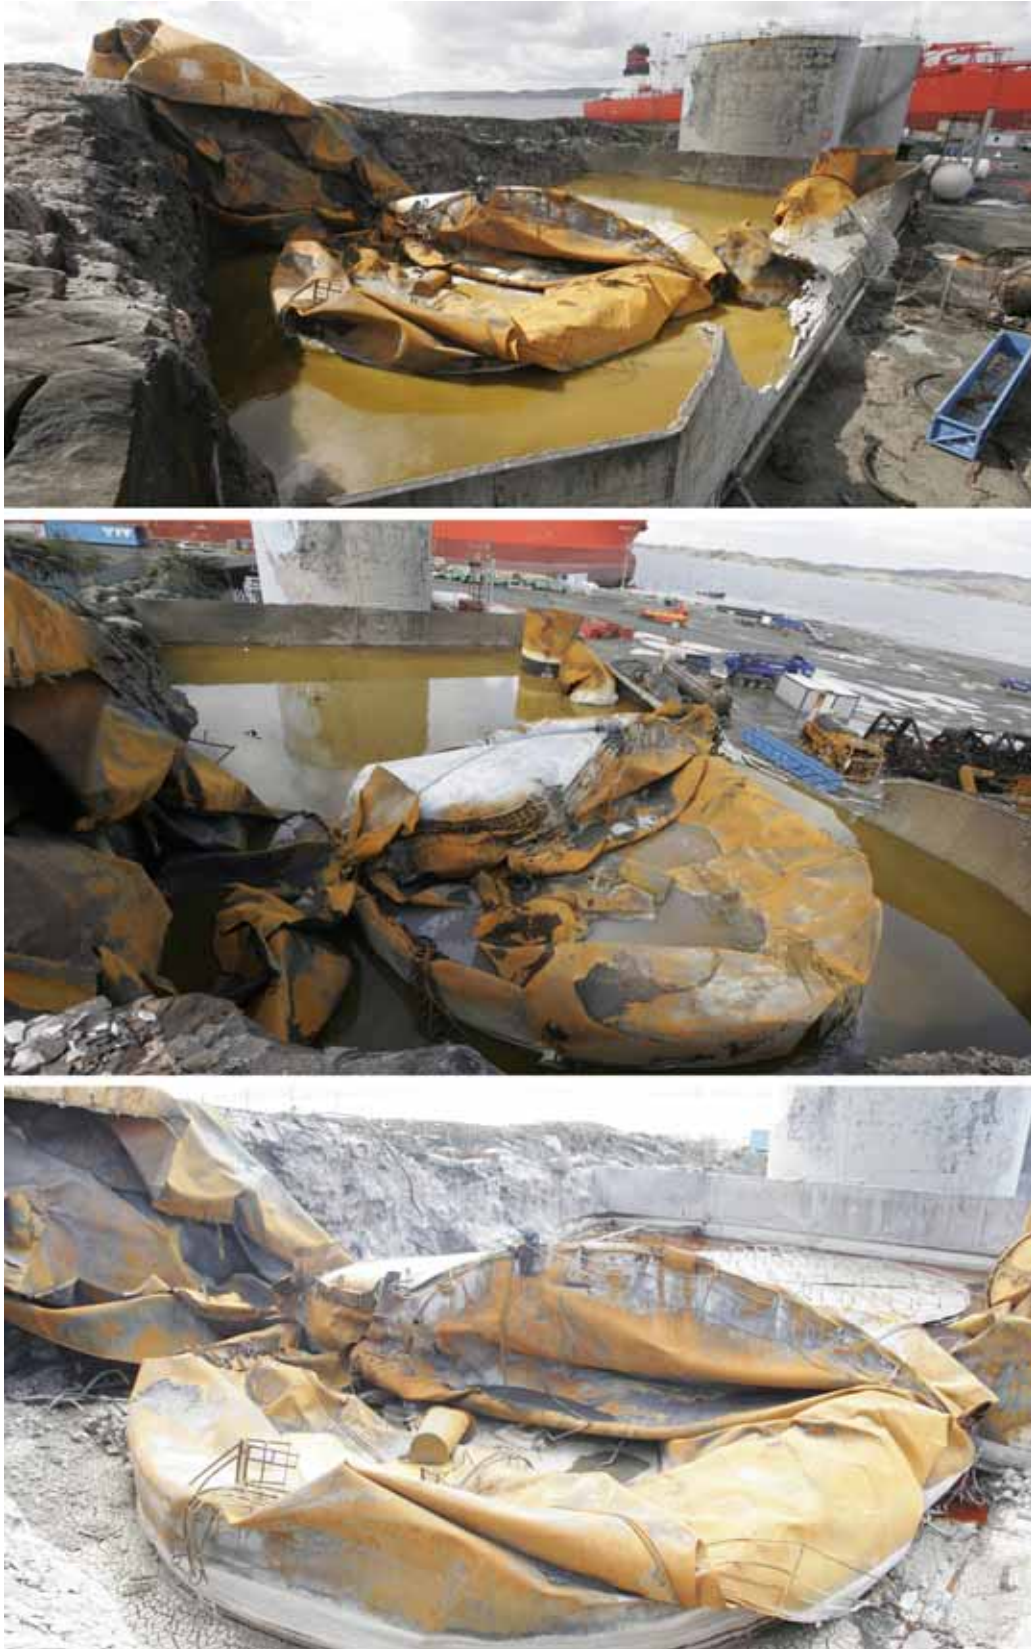
**Figure 3-3** Various pictures of Tank farm II viewed from the north, illustrating the damage to the 5 tanks, the bund, the office building, the two tank lorries, and the vacuum truck; pictures from The Norwegian Police, taken 25<sup>th</sup> May 2007 (above and centre) and 31<sup>st</sup> May 2007 (below).

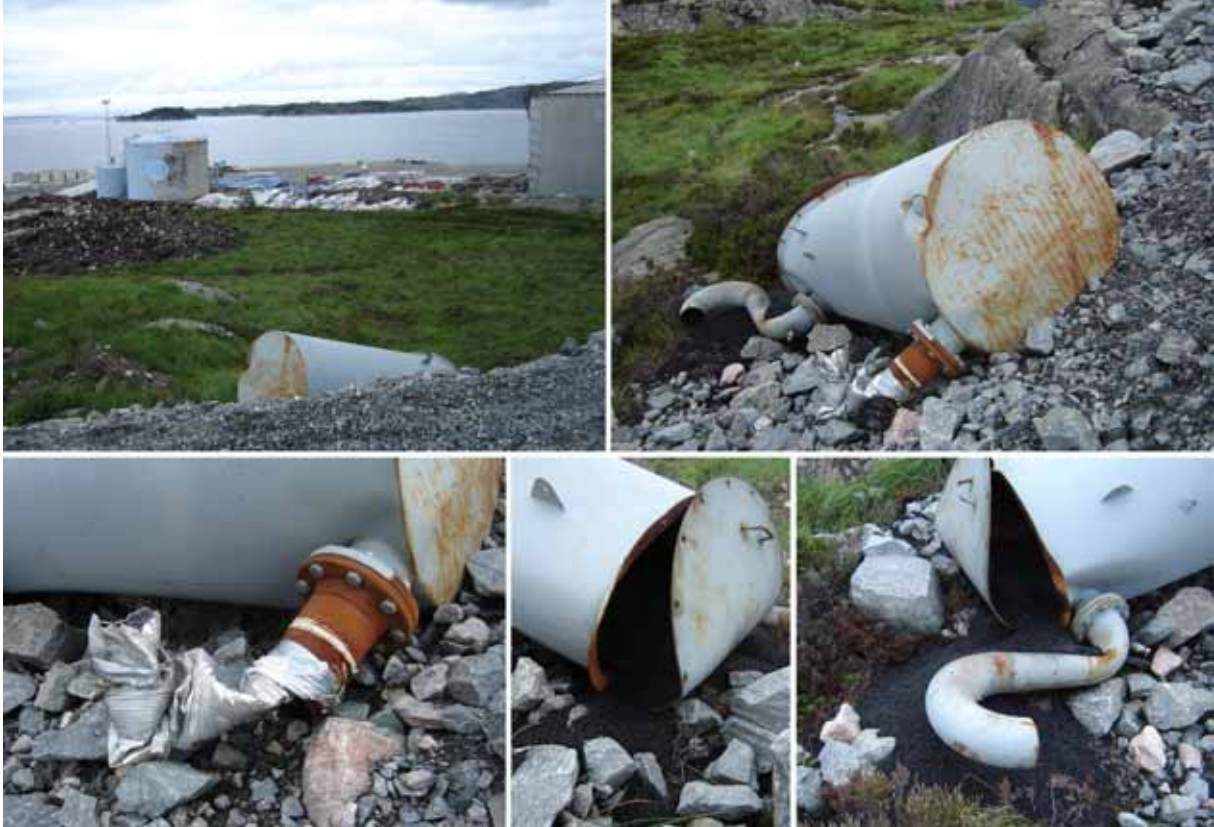
during the second inspection: T. Skjold and K. van Wingerden (both GexCon), and I. Holmås (Police Chief Superintendent at Masfjorden Police Station). The air filter was found in the same position as before, and nothing indicated that it had been moved or opened since the first inspection on 31<sup>st</sup> May 2007.

**Figure 6-3** The air filter from tank T3: position in the terrain (above), inlet with the remains of the flexible pipe (lower left), the lid on top of the filter (lower centre), and the outlet from the filter (lower right).

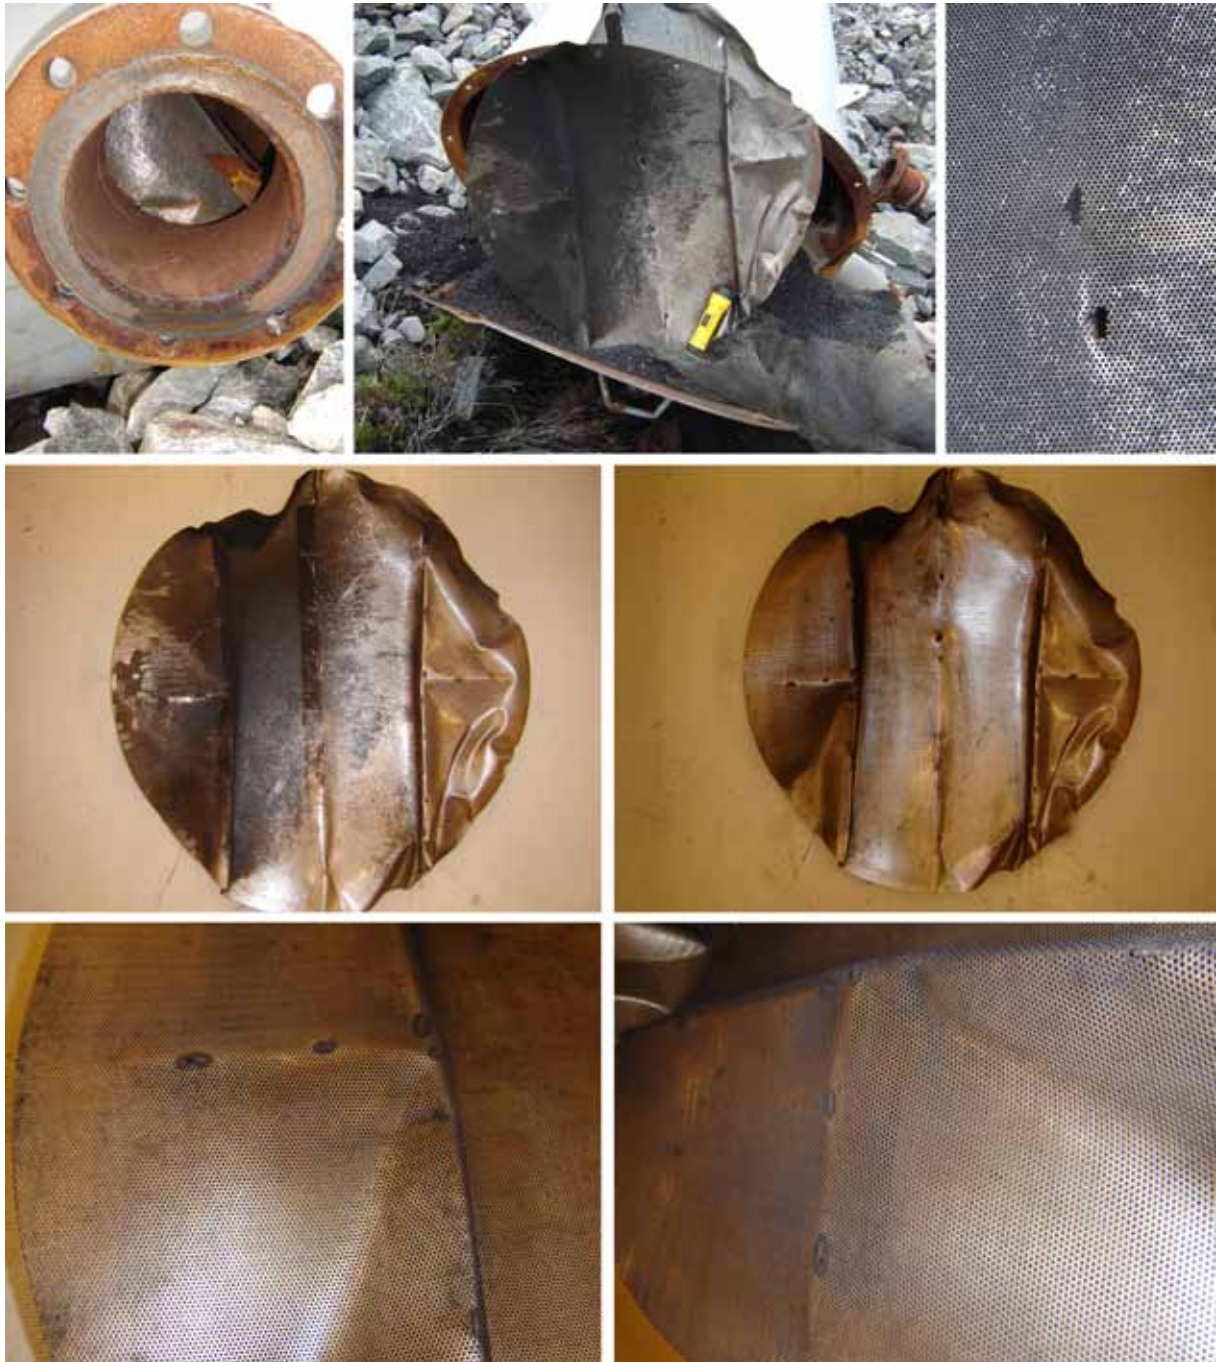
**Figure 6-5** The perforated stainless steel plate from the bottom of the air filter: the plate viewed through the inlet to the canister (upper left); the plate removed from the canister, with a deposit of soot covering about half the surface area (upper centre); holes in the plate at old spot welds, presumably formed during deformation of the plate upon impact of the canister (upper right); the plate before (left middle) and after (right middle) removing the soot deposit; discolouration of the surface of the stainless steel plate, characteristic of heat tinting (lower left and lower right). Photos by T. Skjold.

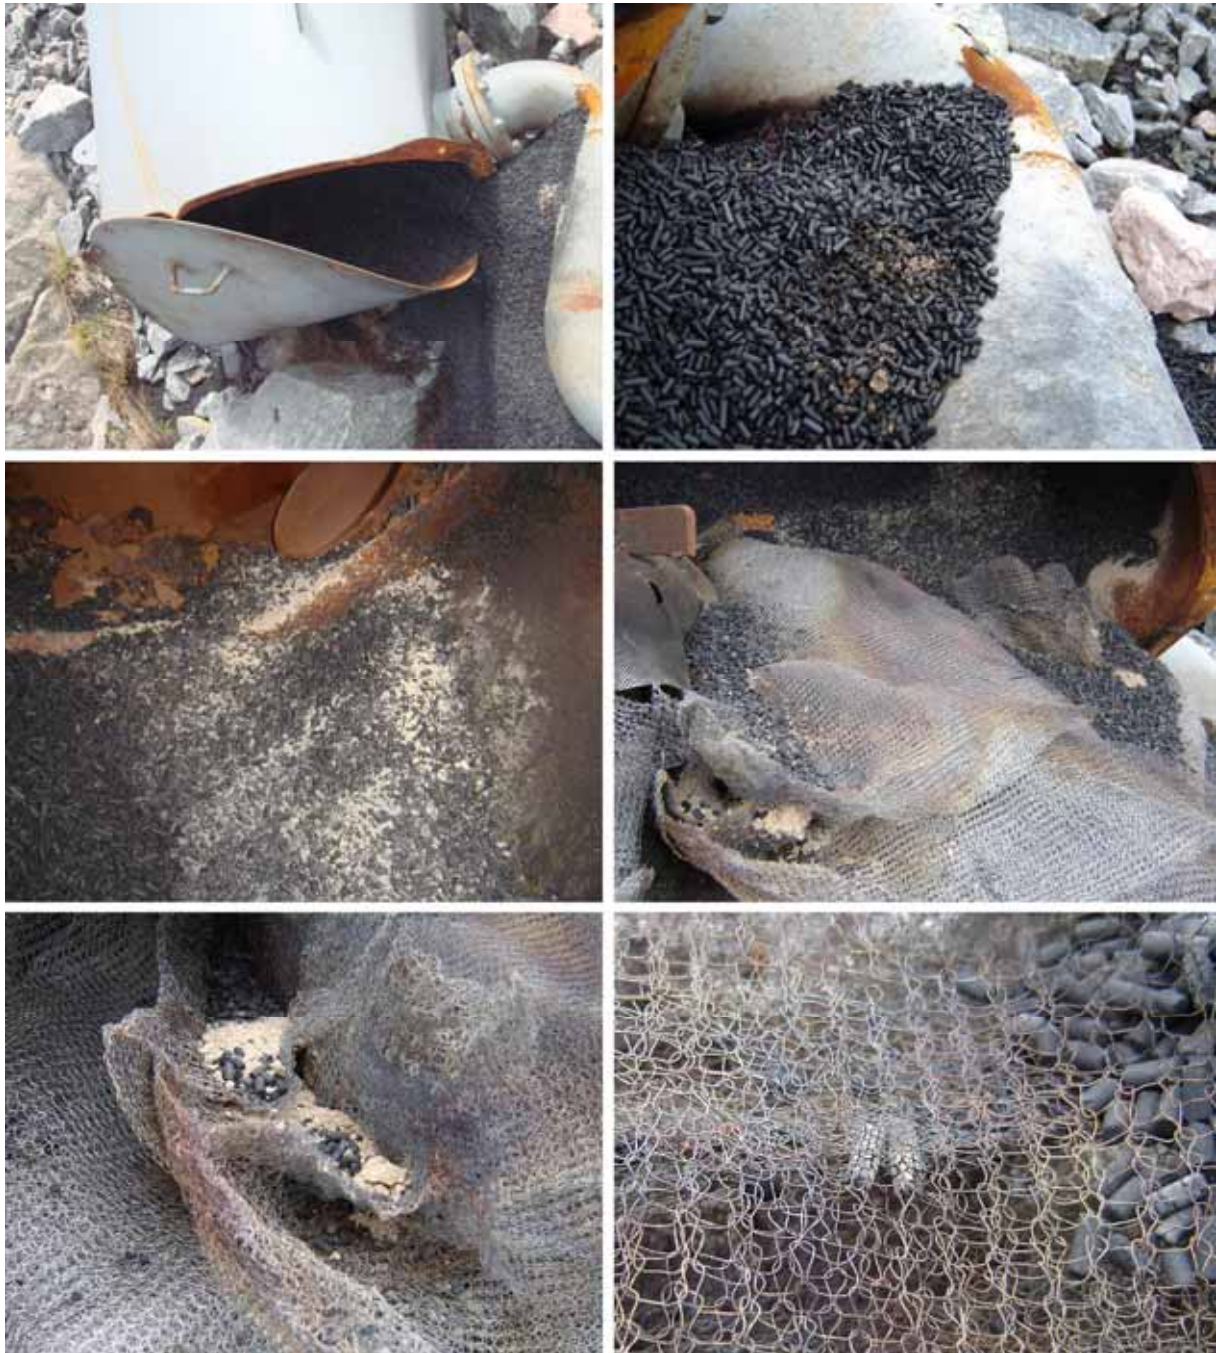
**Figure 6-6** Filter medium, ash like material, and stainless steel wire fabric from the air filter: activated carbon granules poured from the canister, with a pinch of ash-like material (upper left – photo taken by Ø. Larsen during the first on-site inspection on 31<sup>st</sup> May 2007). Close-up of the ash-like material beside the canister (upper right); activated carbon granules with ash like material near the inlet to the canister (middle left); stainless steel wire fabric with evident discolouration (middle right); close-up of stainless steel wire fabric with whitish ash like material (lower left); close-up of activated carbon granules between layers of stainless steel wire fabric (lower right); photos taken by T. Skjold during the second on-site inspection on 18<sup>th</sup> July 2007.

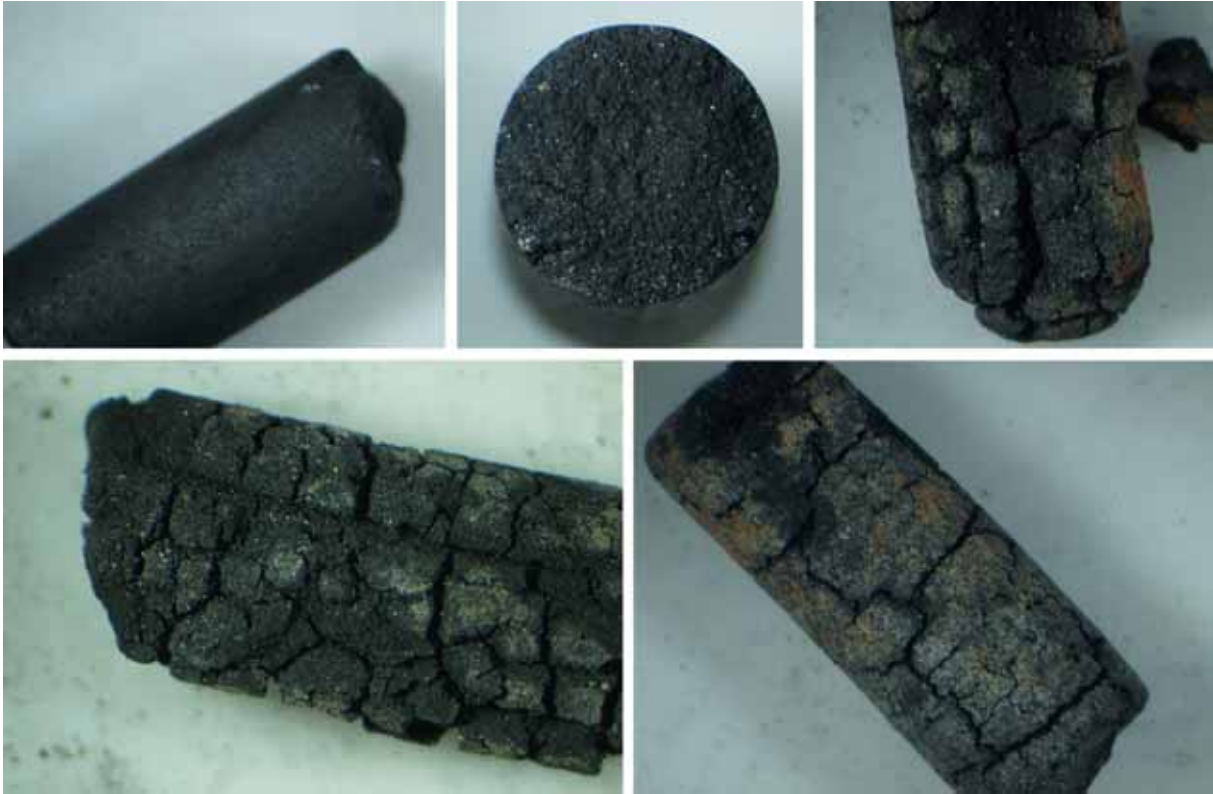
**Figure 6-7** Pictures of activated carbon granules taken through a microscope: granules without visible signs of combustion reactions (upper left and centre), and three single granules with evident signs of combustion reactions (upper right and below); photos by T. Skjold, 15<sup>th</sup> August 2007.

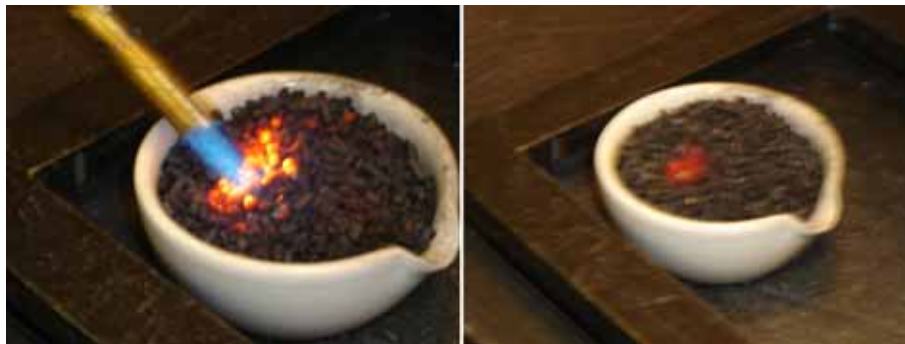
**Figure 6-8** Granules of activated carbon: attempts at igniting activated carbon granules with an open flame did not result in self-sustained combustion reactions (photo by R. Abiven, 12<sup>th</sup> September 2007).
