Journal of Loss Prevention in the Process Industries 19 (2006) 51-59

A study of storage tank accidents

James I. Chang^{a,*}, Cheng-Chung Lin^b

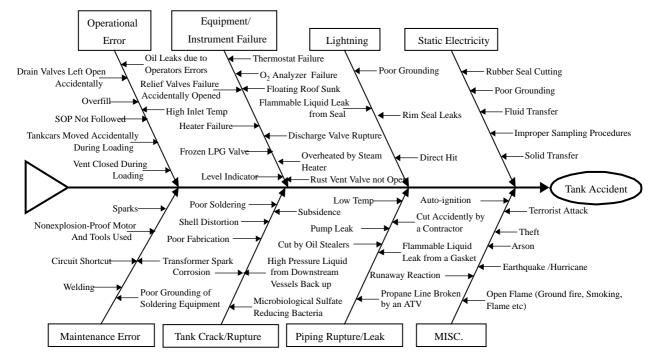
Fig. 1. Fishbone diagram of accident causes.

most frequent cause. The rest were operational error, equipment failure, sabotage, crack and rupture, leak and line rupture, static electricity, open flames etc. To illustrate causes and effects, a fishbone diagram as shown in Fig. 1 was developed. A fishbone diagram as shown in Fig. 2 was also developed for the prevention of accidents.
