# Accident investigation following the Vest Tank explosion at Sløvåg

Revision 03 – English Version

Police District Hordaland, Kripos, and DSB

T. Skjold, K. van Wingerden, R. Abiven, and Ø. Larsen

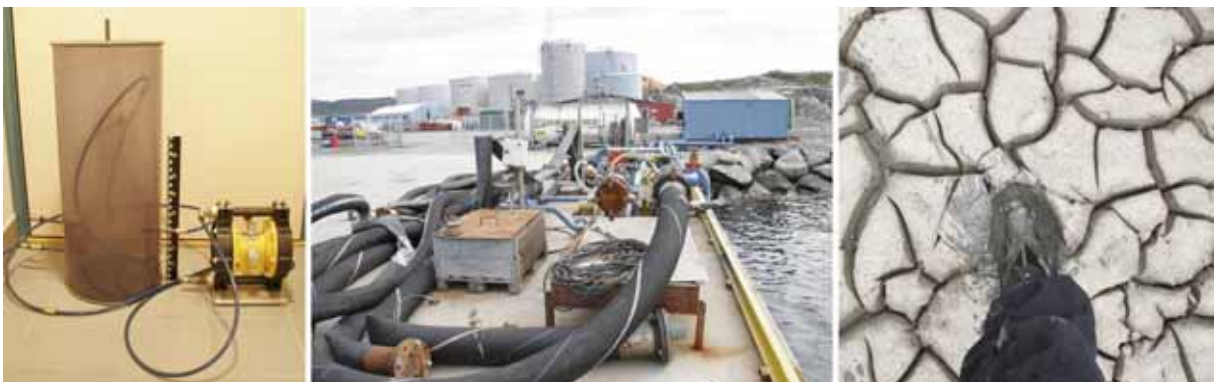
**Figure 1-3** The small-scale apparatus used to investigate the effect of adding hydrochloric acid solution to the solid waste (left); the tank facility seen from the quay, with the lye tank ('De Rijke'), and the flexible tubes used for transferring coker gasoline from the tanker to the tanks (centre); the remaining substance on the ground inside Tank Farm II after the accident (right); pictures provided by the Norwegian Police.

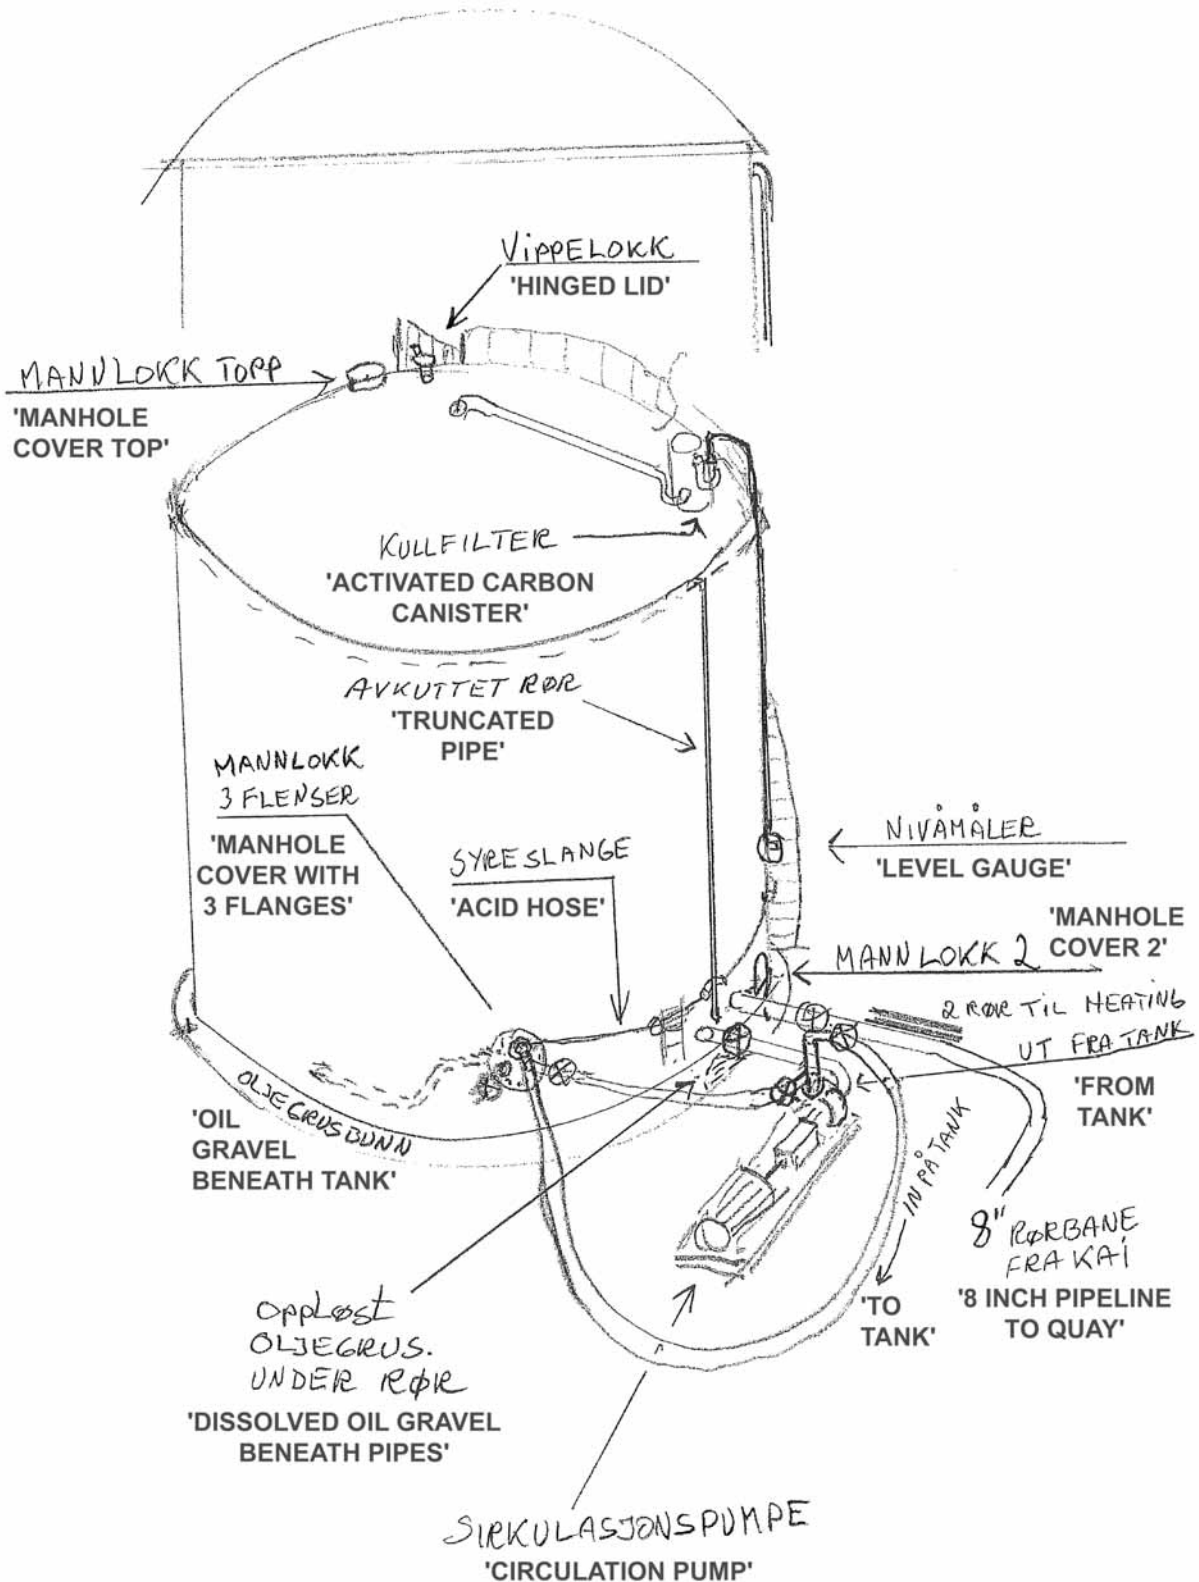
Figure 3-1 is a schematic illustration made by one of the witnesses that shows tank T3 and the system for adding hydrochloric acid while circulating the contents of the tank. The following points should be noted, since they are relevant for the discussion in chapters 4 to 6:

- The heating system in the bottom of the tank was not in use.

**Figure 3-1** Schematic sketch illustrating tank T3 prior to the accident. The drawing shows the openings in the tank, the truncated pipe sealed with adhesive tape, the system for adding acid while circulating the content on the tank, and the air filter on top of the tank. Witness C (Table 3-1) made the drawing during an examination at Masfjorden Police Station on 13<sup>th</sup> June 2007, and the authors added the printed text during the translation of the English version of this report.

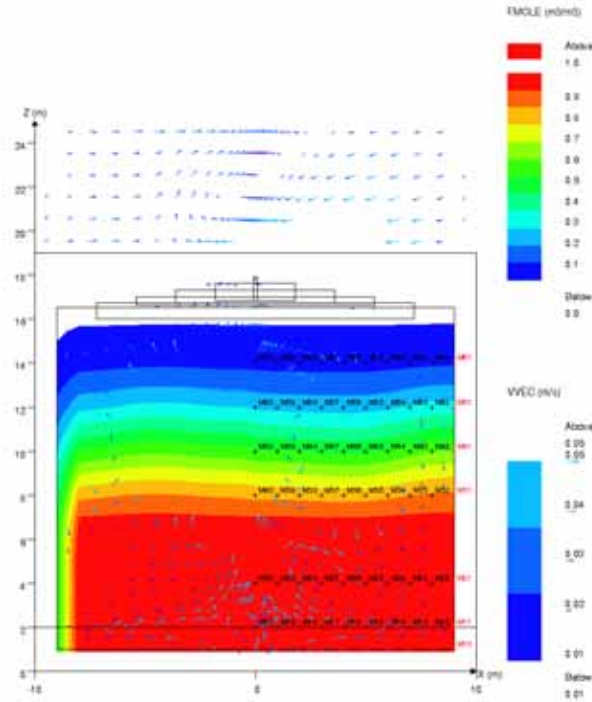
Figure 5-2 illustrates the simulated concentration gradient after 71 minutes in a vertical cross-section of the tank, for a release of vapour at 35 °C from a liquid surface. The flammable mixture has reached the top of the tank, while the concentration close to the liquid surface is above the upper flammability limit. The flow velocities resulting from buoyancy are approximately 4-5 cm s<sup>-1</sup>. Figure 5-3 shows how the simulated fuel concentration develops in the monitor points along the centre of the tank for the same simulation. Figure 5-4 illustrates the effect of decreasing the density of released vapour (by increasing the temperature, but reduced molecular weight would in principle have given similar results), on the simulated mole fractions of fuel vapour near the roof of the tank. Reduced density increases the buoyancy, and the flammable mixtures reach the top of the tank faster.

**Figure 5-2** Vertical cross-section of tank T3 illustrating the simulated mole fraction of fuel vapour and velocity vectors after a 71 minutes release from a liquid surface at elevated temperature; total release rate  $1 \text{ kg s}^{-1}$ ; release temperature  $35 \text{ }^\circ\text{C}$ .

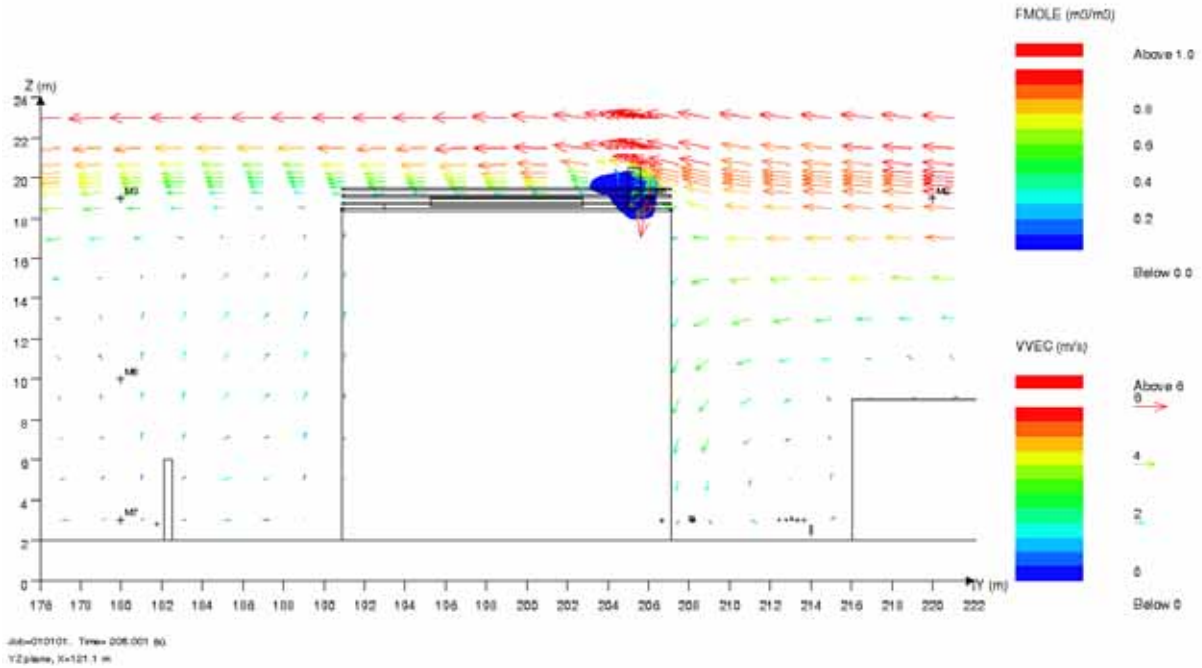
The first simulation involves a leak with release rate 1 kg s<sup>-1</sup>, pointing downwards from the position of the exit from the air filter, and wind from the south at a speed of 6 m s<sup>-1</sup>. Figure 5-9 shows a three-dimensional representation of the steady-state gas cloud formed by this release, and Figure 5-10 shows the cloud in a vertical cross-section through the tank. Figure 5-11 summarizes the simulated mole fractions of fuel vapour in the four monitor points shown in Figure 5-10. This simulation suggests that no traces of fuel reach the monitor point upstream of the tank, and that the concentrations in the monitor points downstream of the release are of the order 0.01-1 ppm, i.e. significantly lower than the lower flammability limit for the relevant fuels (Table 5-2 suggests LFL > 1.3 vol%). Since the wind field quickly dilutes the fuel gas with air, the explosive atmosphere is limited to a small region near the release point, and all concentrations at ground level are orders of magnitude lower than LFL.

**Figure 5-9** Stabilised gas cloud on the roof of tank T3 after 3.5 minutes of a constant rate release ( $1 kg s^{-1}$ ) from the outlet of the air filter (wind speed  $6 m s^{-1}$ ). The picture shows Tank farm I in front, and Tank farm II in the background. The blue surface contour indicates 1 per cent by volume of fuel (i.e. presumably somewhat below LFL).

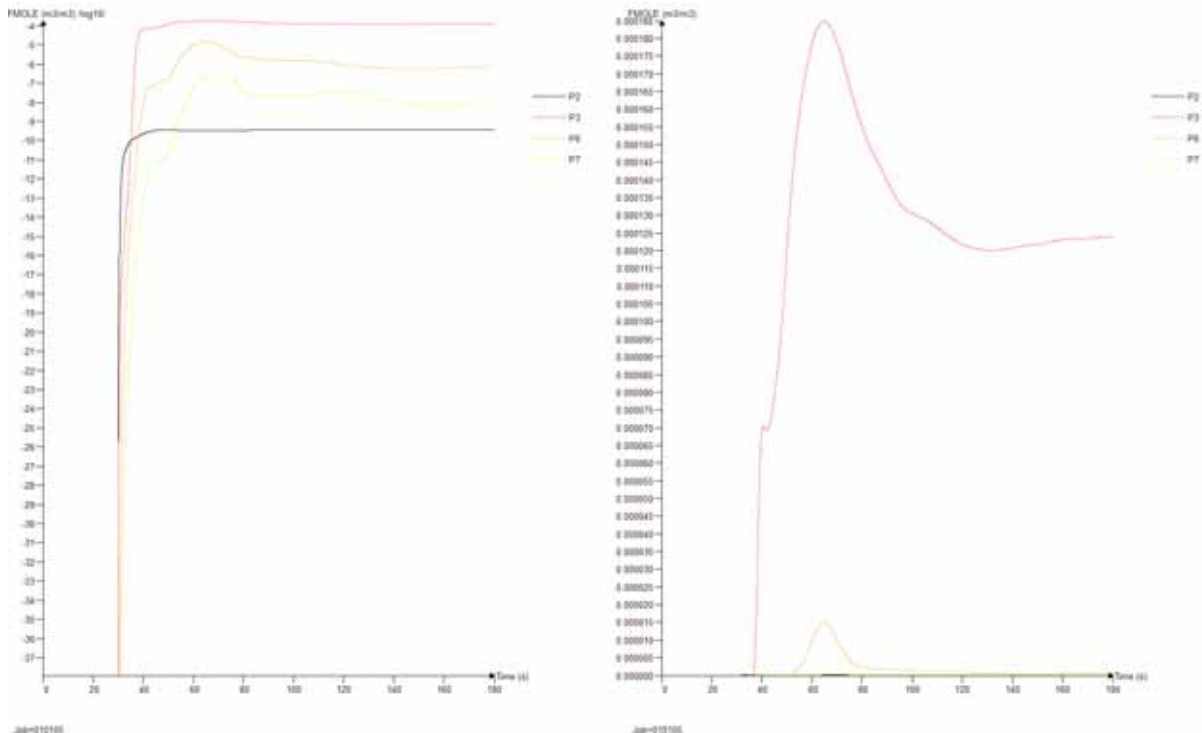
Two additional simulations were performed to investigate the sensitivity of the results discussed above: one simulation with release rate 9 kg s<sup>-1</sup> and wind speed 6 m s<sup>-1</sup>, and one simulation with release rate 1 kg s<sup>-1</sup> and wind speed 3 m s<sup>-1</sup>. The 9 kg s<sup>-1</sup> release rate implies an internal overpressure exceeding the design pressure of the tank (for the given area of the outlet), and a wind speed of 3 m s<sup>-1</sup> is about half the characteristic wind speed measured at Mongstad (see Figure 3-4). Figure 5-12 shows the simulated gas cloud from the simulation with a release rate of 9 kg s<sup>-1</sup>, and Figure 5-13 summarizes the simulated mole fractions of fuel vapour in the four monitor points shown in Figure 5-10. Figure 5-14 shows the simulated gas cloud from the simulation with wind speed of 3 m s<sup>-1</sup>. Both scenarios produce significantly larger gas clouds than the scenario with release rate 1 kg s<sup>-1</sup> and wind speed 6 m s<sup>-1</sup>, but the fuel concentrations at ground level are nevertheless significantly below the lower flammability limit.

**Figure 5-12** Stabilised gas cloud on the roof of tank T3 after 3.5 minutes of a constant rate release ( $9 \text{ kg s}^{-1}$ ) from the outlet of the air filter (wind speed  $6 \text{ m s}^{-1}$ ). The gas cloud indicated by blue colour has a fuel concentration of at least 1 per cent by volume, and is therefore representative for the extent of the explosive atmosphere near the release point; the fuel cloud is significantly larger than for the scenario with a release rate of  $1 \text{ kg s}^{-1}$ , illustrated in Figure 5-9.

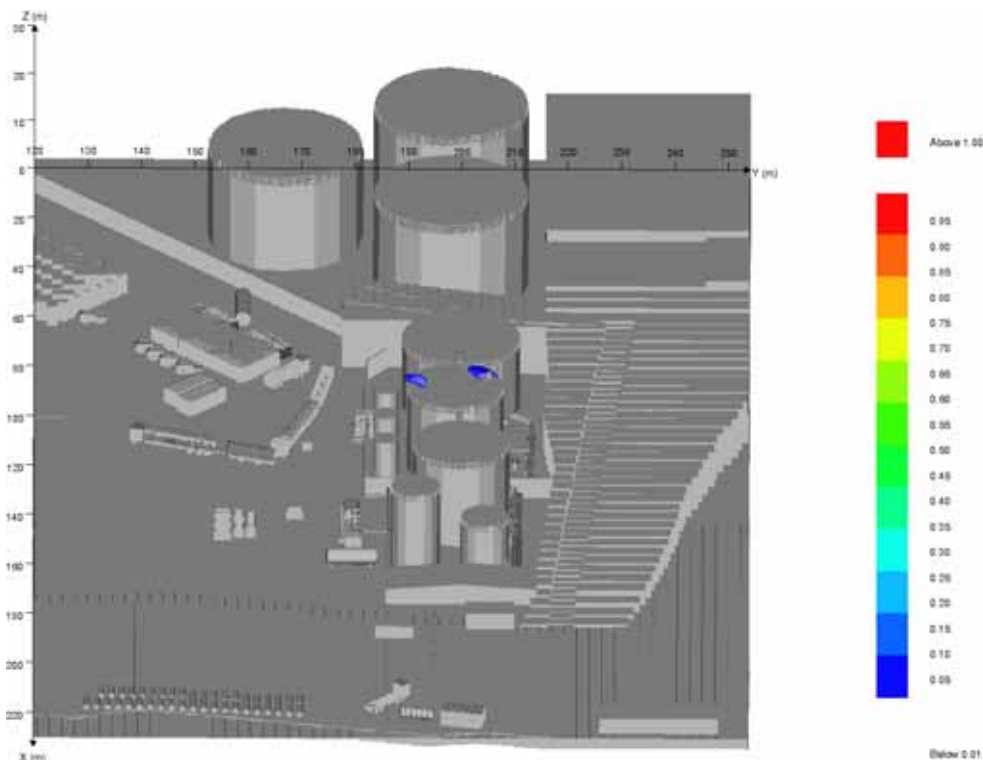
**Figure 5-14** Stabilised gas cloud on the roof of tank T3 after 3.5 minutes of a constant rate release ( $1 \text{ kg s}^{-1}$ ) from the outlet of the air filter (wind speed  $3 \text{ m s}^{-1}$ ). The picture shows only Tank farm II. The gas cloud indicated by blue colour has a fuel concentration of at least 1 per cent by volume, and is therefore representative for the extent of the explosive atmosphere near the release point; the fuel cloud is somewhat larger than for the scenario with wind speed  $6 \text{ m s}^{-1}$ , illustrated in Figure 5-9.

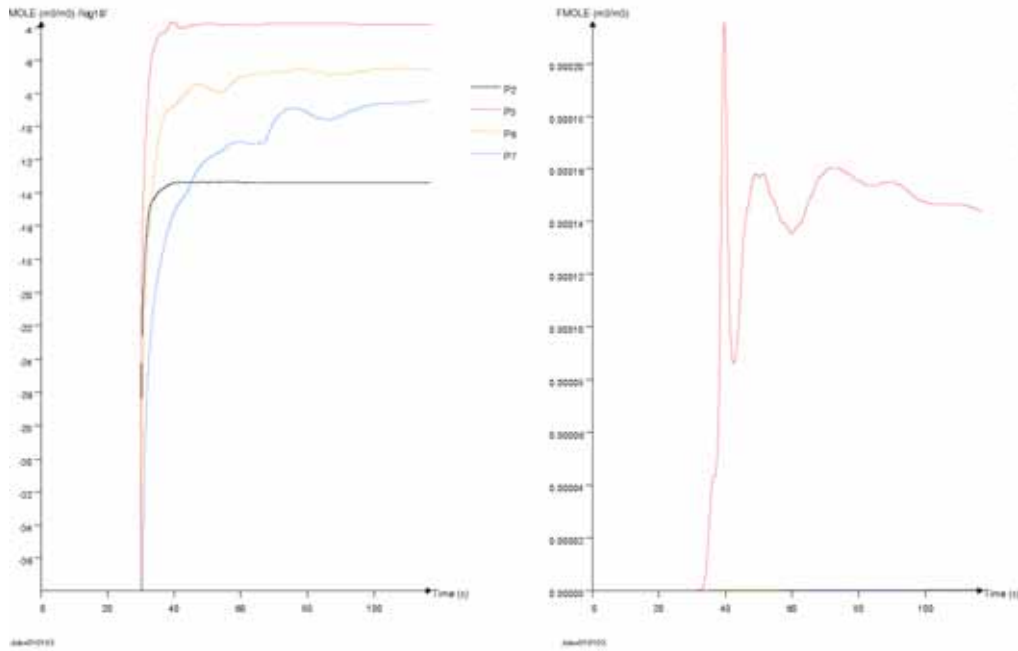
The fourth simulated scenario assumes that the hinged lid on top of the tank was open, in addition to the flow of flammable gas through the air filter. Based on the cross section of the opening and the weight of the lid, it was estimated that the lid would open at an internal overpressure of about 11 millibars, corresponding to a release rate of about  $1 \text{ kg s}^{-1}$  from a six inch opening. Hence, this simulation included two outlets with a release rate of  $1 \text{ kg s}^{-1}$  each. Figures 5-15 and 5-16 show the simulated gas clouds from the two leaks, and the simulated mole fractions of fuel vapour in the four monitor points shown in Figure 5-10. As for the previous simulations, the extent of the explosive atmosphere generated in this simulation is also quite limited, and all fuel concentrations near the ground are significantly below LFL.

**Figure 5-15** Stabilised gas clouds on the roof of tank T3 after 3.5 minutes of two parallel constant rate releases (each  $1 \text{ kg s}^{-1}$ ) from the outlet of the air filter and from the outlet by the hinged lid (wind speed  $6 \text{ m s}^{-1}$ ). The picture shows all the three tank farms. The gas cloud indicated by blue colour has a fuel concentration of at least 1 per cent by volume, and is therefore representative for the extent of the explosive atmosphere near the release point; each fuel cloud is similar in volume to the cloud from the scenario with only one release, illustrated in Figure 5-9.

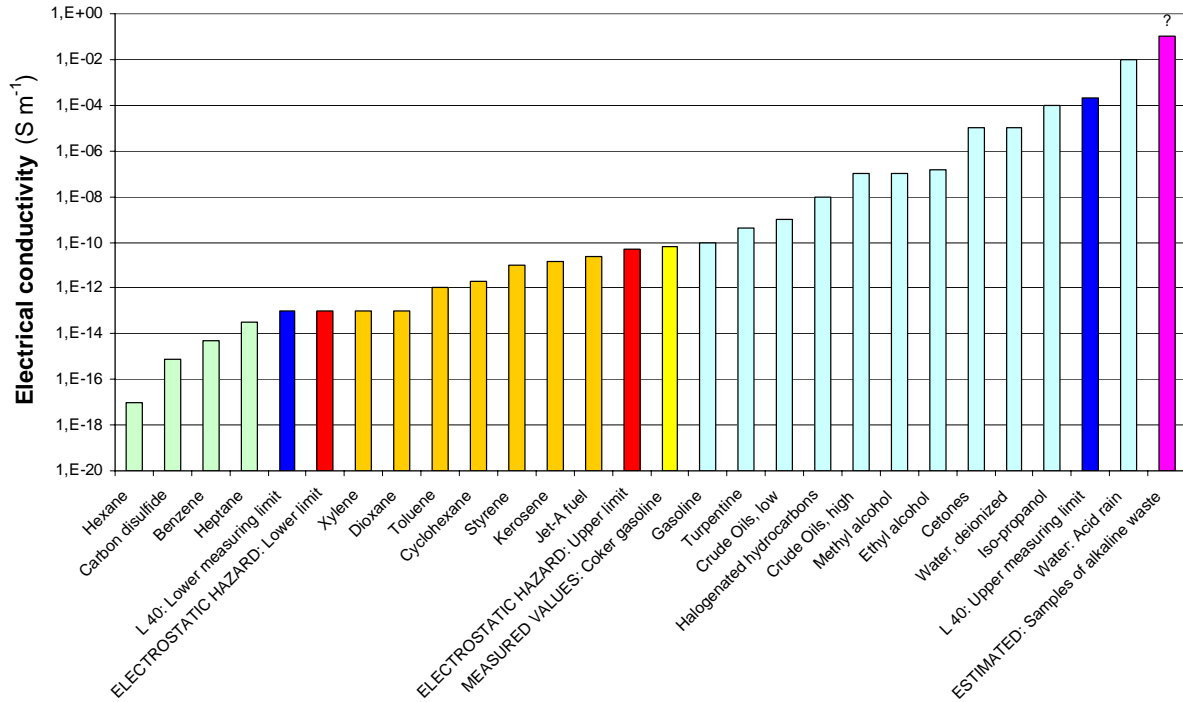
Figure 6-2 illustrates typical values of electrical conductivity for various liquids, including the measured results for the samples summarised in Table 6-1. The results for the samples of alkaline waste show that the electrical conductivity is higher than the upper limit of the measuring range for the conductivity meter, and hence significantly higher than conductivities normally associated with electrostatic ignition hazards. The measured conductivity of the coker gasoline samples (represented by the yellow column in Figure 6-2) is just above the upper limit of hazardous conductivities (the red column in the centre). It is possible that the conductivity of coker gasoline was somewhat reduced when polar components like mercaptans were transferred to the sodium hydroxide solution during the treatment at Vest Tank. Hence, it is not straightforward to predict whether the conductivity of 'cleaned' coker gasoline would fall within the hazardous area, i.e. between the two red columns in Figure 6-2. The likelihood of generating hazardous levels of electrostatic charge on the liquid surface inside tank T3 is nevertheless very small. Most of the liquid in the tank had very high conductivity, and there was no splash filling of liquid into the tank. Hence, it is not straightforward to envisage how efficient charge separation could take place in this system.

Based on the properties of the liquids in the system, and the procedures used for adding hydrochloric acid to the alkaline waste, it seems highly unlikely that electrostatic discharges may have ignited the explosive atmosphere inside tank T3 on 24<sup>th</sup> May 2007.

**Figure 6-2** Characteristic and measured values of electrical conductivities for various liquids. The liquids represented by the light-green columns on the left normally have too low conductivities to accumulate hazardous levels of electrostatic charge; however, a small amount of impurities can significantly influence the conductivity. The two red columns represent the lower and upper limits of hazardous conductivities, and the intervening orange columns represent liquids that may accumulate hazardous levels of electrostatic charge. The liquids represented by the light-blue columns on the right generally have too high conductivities to accumulate hazardous levels of electrostatic charge. The measured conductivities for the three samples of coker gasoline are represented by the yellow column ( $66 \pm 5 \text{ pS m}^{-1}$ ), and estimated conductivities for the three samples of alkaline waste are represented by the pink column (significantly above  $0.2 \text{ mS m}^{-1}$ ). The measuring range of the liquid conductivity meter, Model L40 from Wolfson Electrostatics Ltd., lies between the two dark-blue columns in the diagram.

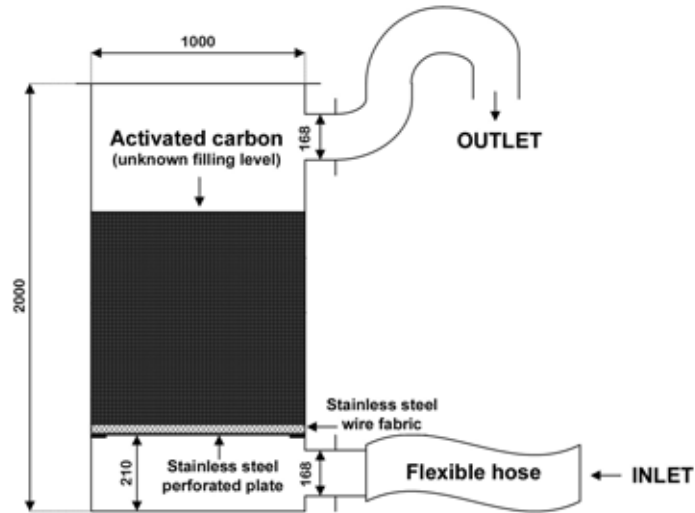
Figure 6-4 shows a principle drawing of the air filter. The filter vessel, or canister, was shaped like a cylinder, with height 2 meters and diameter 1 meter (total internal volume 0.79 m<sup>3</sup>). Figure 3-1 indicates the original position of the filter along the railing on the roof of tank T3. A six-inch flexible hose connected the tank to the inlet of the canister. Air and vapours would enter in the bottom of the canister, and pass through the filter medium before exiting the upper part of the canister through a swan-neck.

The filter medium was activated carbon granules of type 'AIRPEL 10' from Tøssebro AS, specially prepared for purifying air (e.g. high adsorption capacity). A perforated plate of stainless steel and several layers of stainless steel wire fabric supported the granules. Two screws held the flanged lid on the canister in place (the rest of the screws were missing), and the lid had been somewhat deformed in the explosion (Figure 6-3). The exact level of filling in the filter prior to the accident is unknown, but both witness statements and the examination of the filter suggest that the top layer of activated carbon granules was close to the lower edge of the outlet pipe (see Figure 6-4).

**Figure 6-4** Principle drawing illustrating a vertical cross-section of the air filter (drawing by K. van Wingerden; dimensions in millimetres).
